Healthy Homes Standards Assessment

Property Address: 31 Sample St, Fendalton, Christchurch, Can 8014

20211102-31-Sample-St

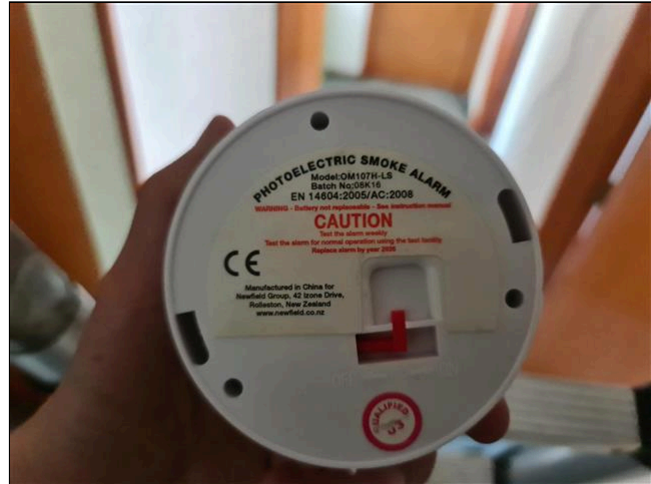
2.0 Item 3(Picture)

2.0 hallway smoke alarm long-life battery expire in 2026.

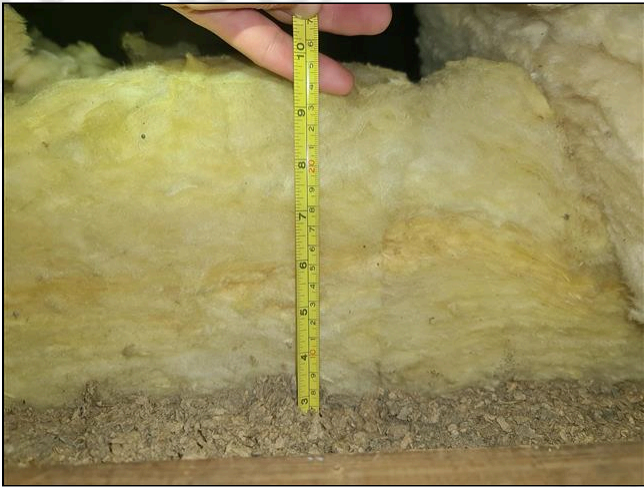
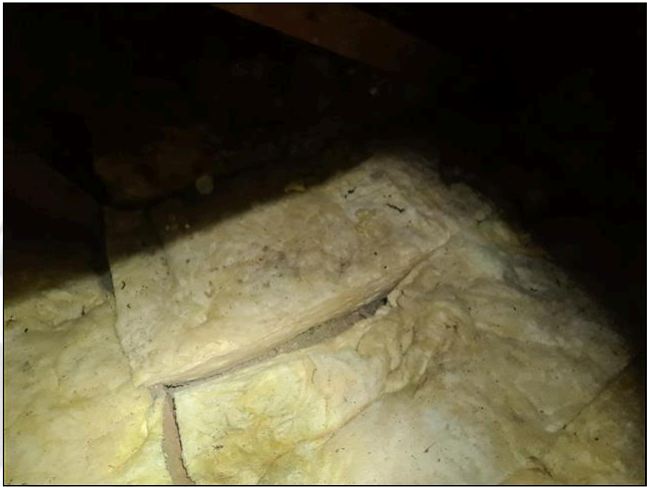
3.0 There are old loose-fill type insulation and recently installed Bradford Gold fibreglass ceiling R3.6 insulation present in the roof cavity. The R3.6 ceiling insulation segments are over 180mm. Overall, The total thickness of loose-fill type insulation and fibreglass insulation is above the requirement of Healthy homes standards-R3.3.

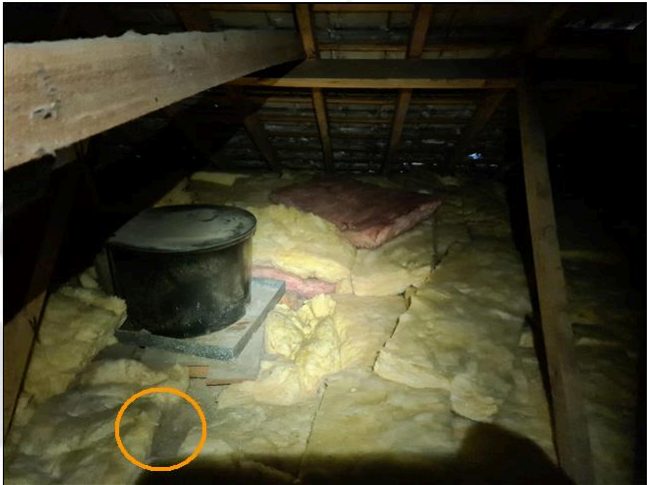
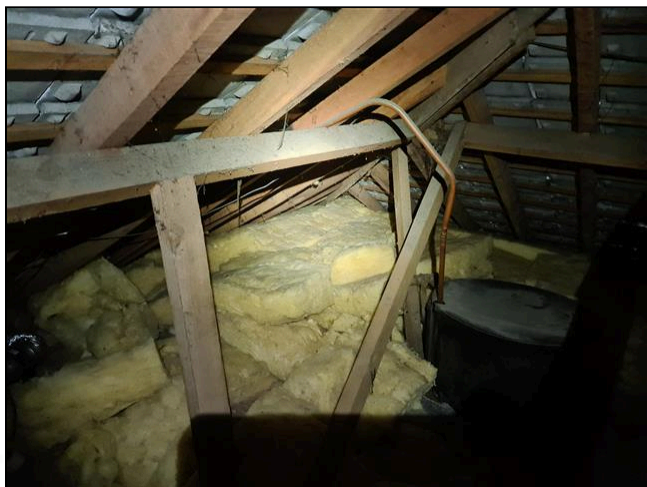
3.1 Insulation with gaps, some are piled up, and some are scattered around, However not in major.

Insulation with gaps, some are piled up, and some are scattered around, However not in major.

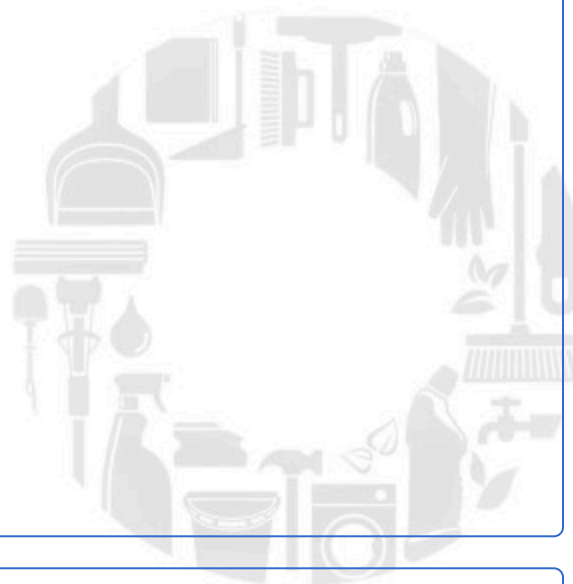
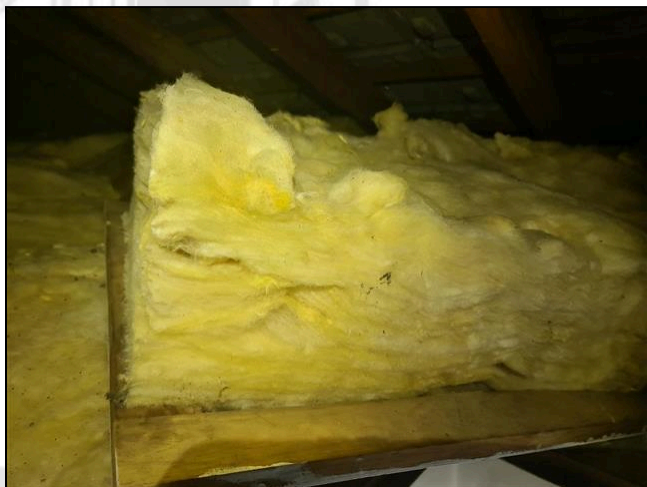
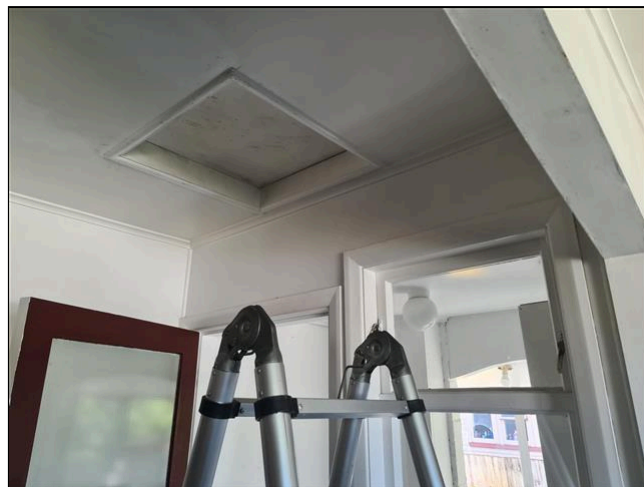
3.2 Insulation above the manhole.

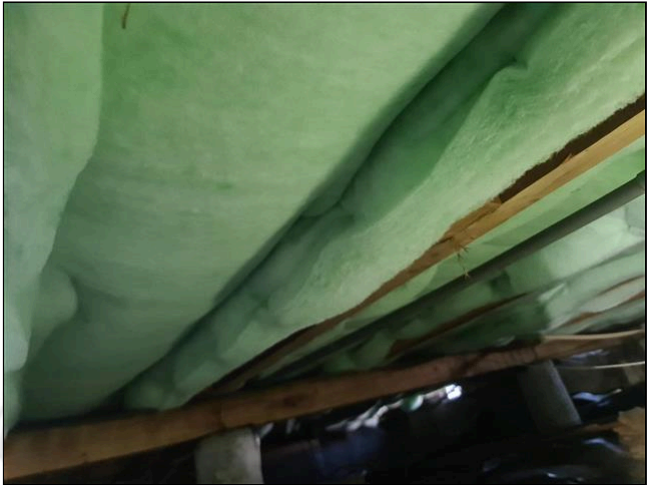
4.0 Item 2(Picture)

4.0 Under floor Greenstuf R1.5 insulation.

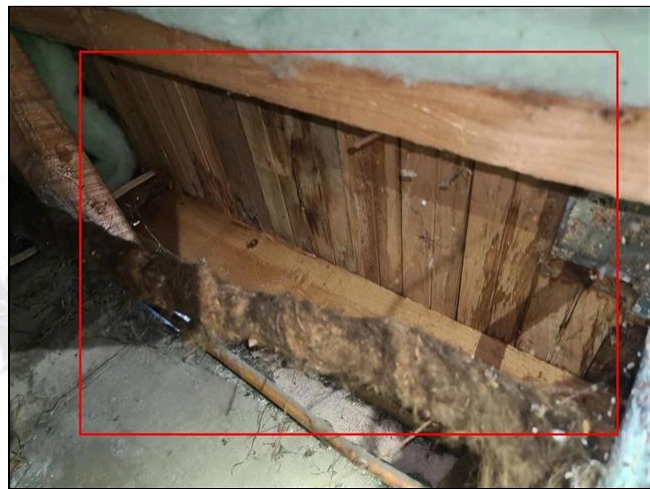
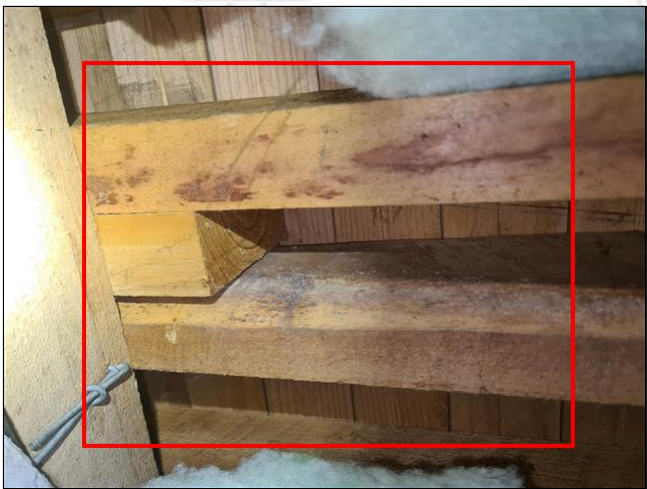
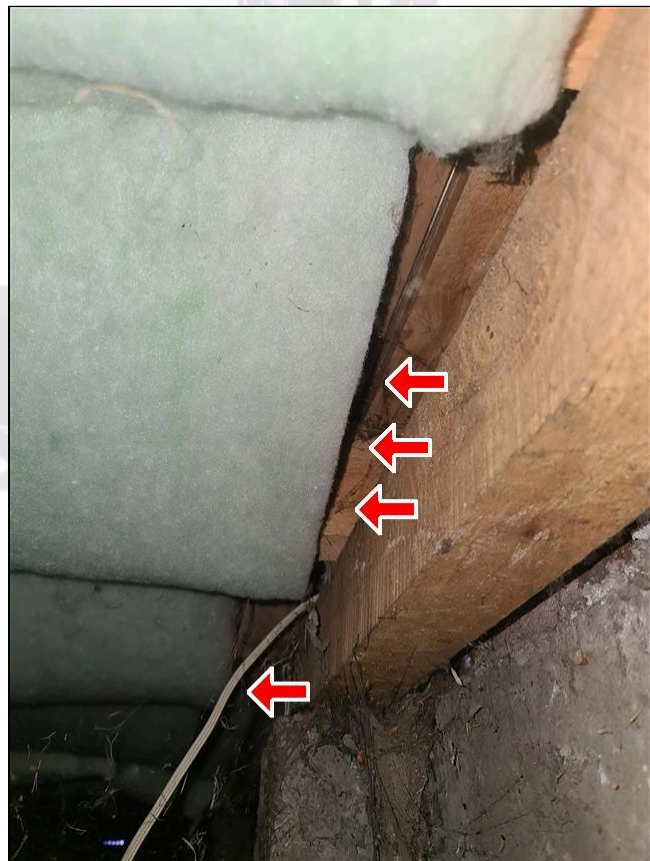
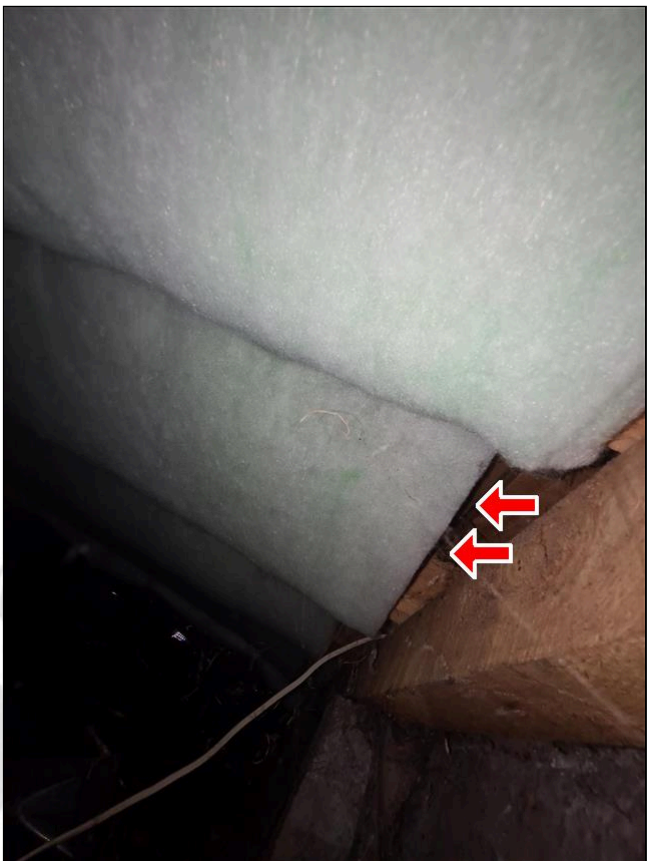
4.1 There are missing insulation close to the foundation concrete. And about 2/3 insulation has been installed with air gaps.

There are missing insulation close to the foundation concrete. And about 2/3 insulation has been installed with air gaps.

Please refer [New Zealand Standard \(Energy efficiency - Installing bulk thermal insulation in residential buildings\) 4246:2016](#) section 7.3. to see correct actions:

Action 6: "Run the product in a continuous length between the floor joists and over the main bearers. Ensure that any

designated outer layer of the insulation product is facing downwards. In situations where there are blocks between floor joists do not run insulation over these. Make sure insulation stops and starts each side of any such blocking.

Action 7: "Install insulation so that it touches the underside of the floor, without being compressed. Pull insulation tight between the joists to ensure there is no air gap or air movement between the insulation material and the floor, but not so tight as to affect the material loft or thickness"

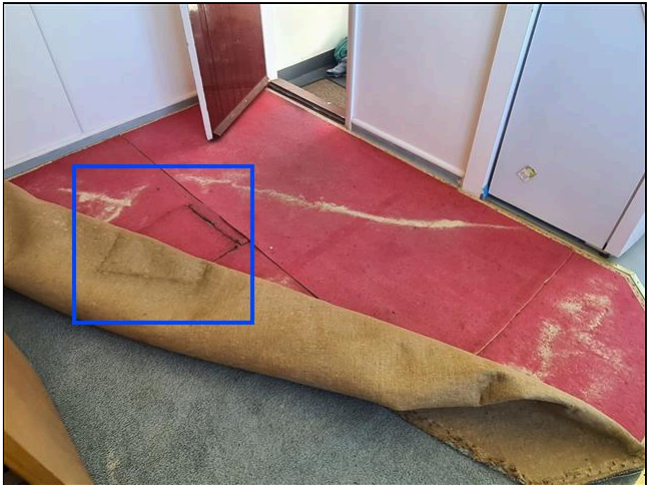
4.2 Item 2(Picture)

4.2 Manhole cover with R1.5 underfloor insulation.

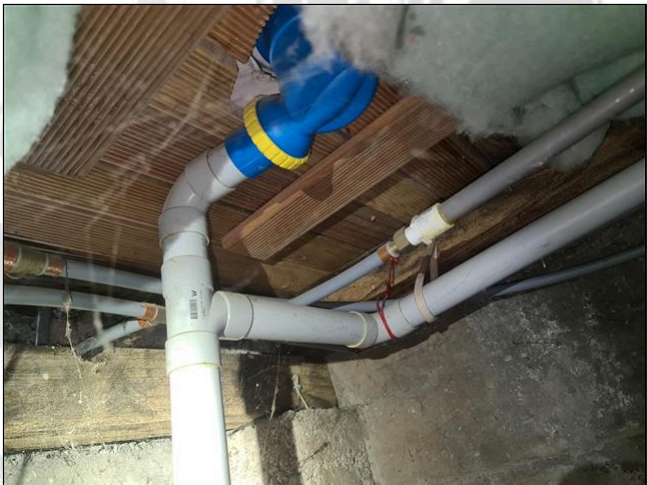
4.3 Item 2(Picture)

4.3 Correct distance around objects in the subfloor.

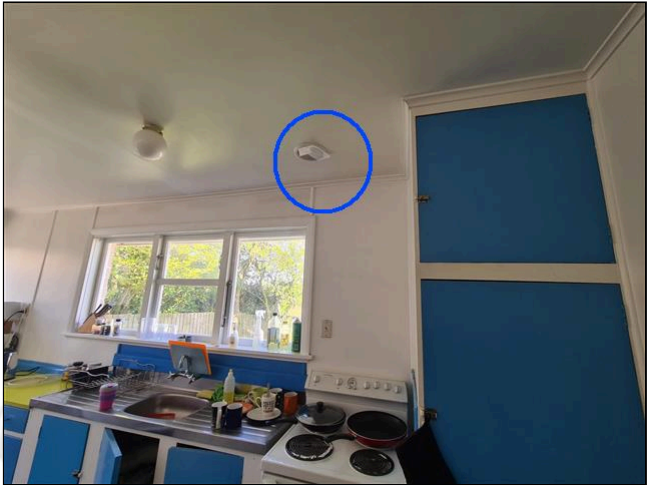
5.0 Item 2(Picture)

5.0 Rangehood in the kitchen.

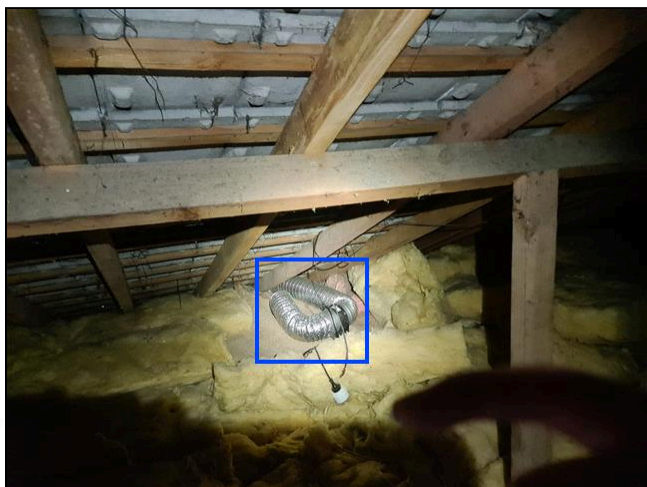
5.2 Item 1(Picture)

5.2 Rangehood ducting in the roof cavity.

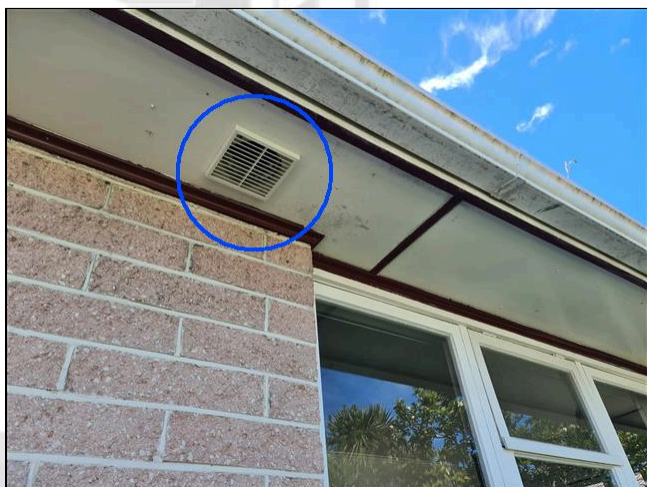
5.3 Item 1(Picture)

5.3 Rangehood external vent. air flows out when rangehood is working.

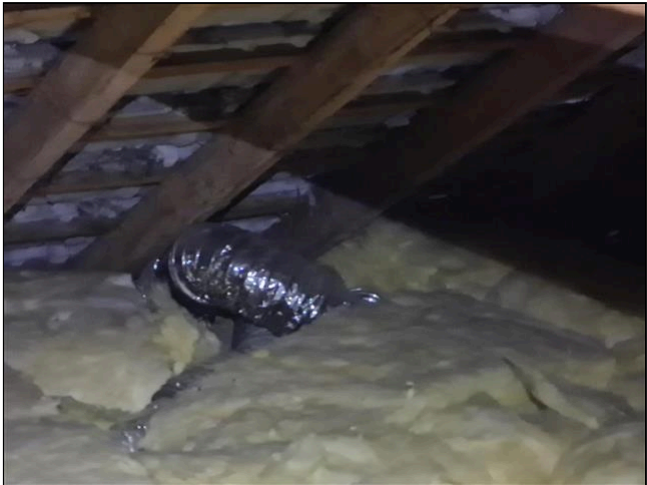
6.2 Item 2(Picture)

6.2 Bathroom ducting pipe in the roof cavity.

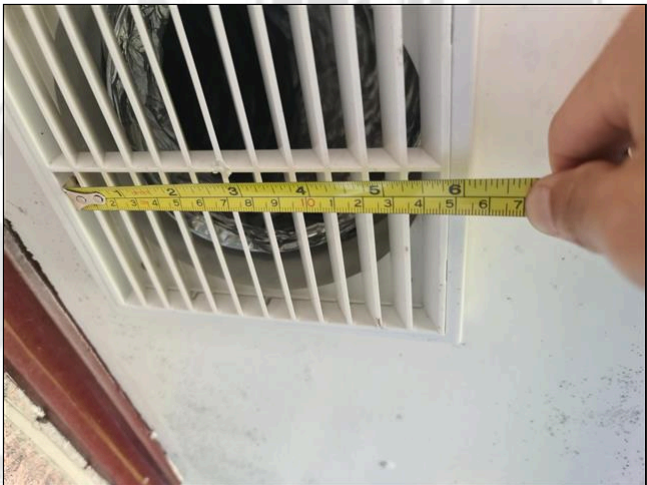
6.3 Item 2(Picture)

6.3 Bathroom fan external vent in blue area. air flows out when rangehood is working.

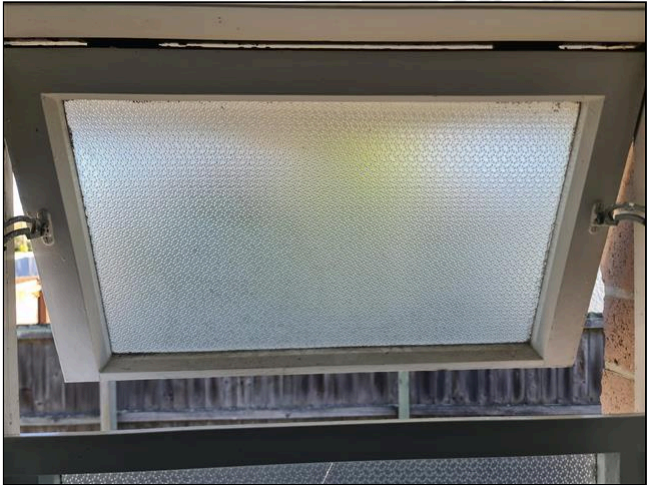
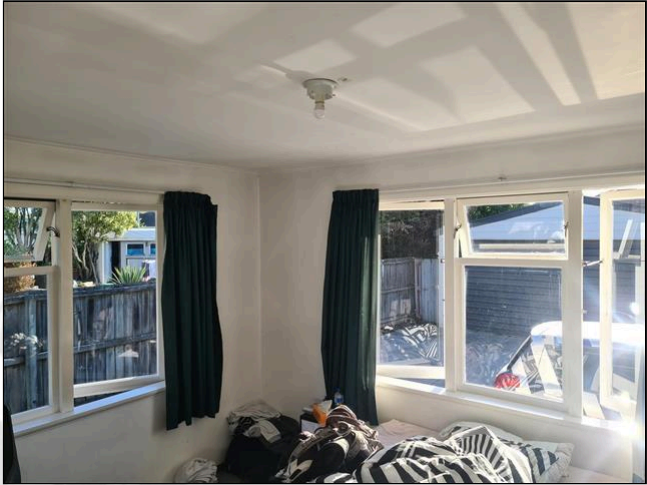
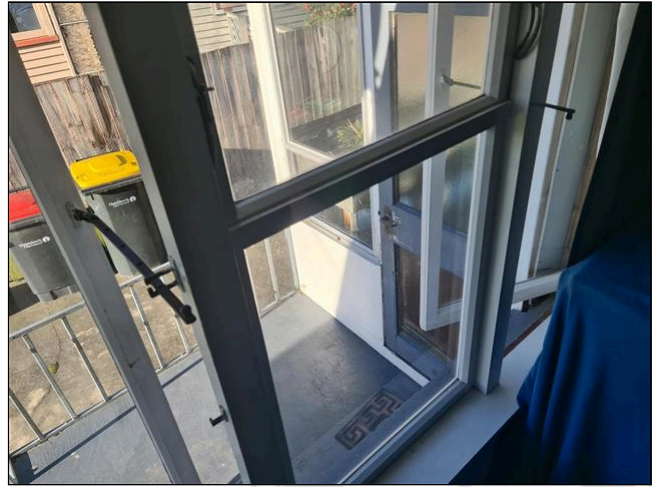
7.0 Openable windows.

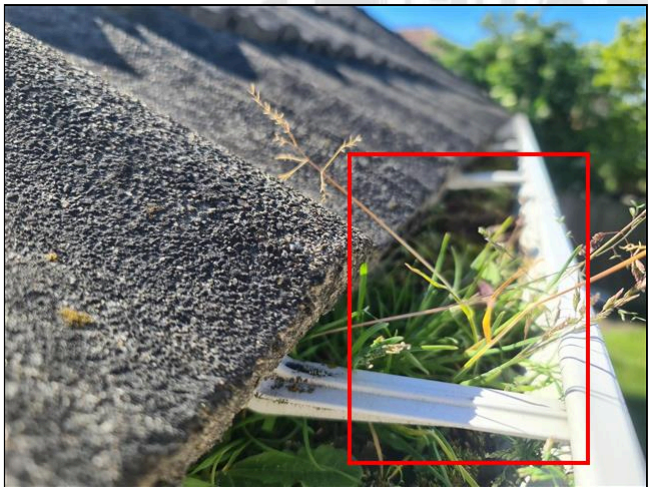
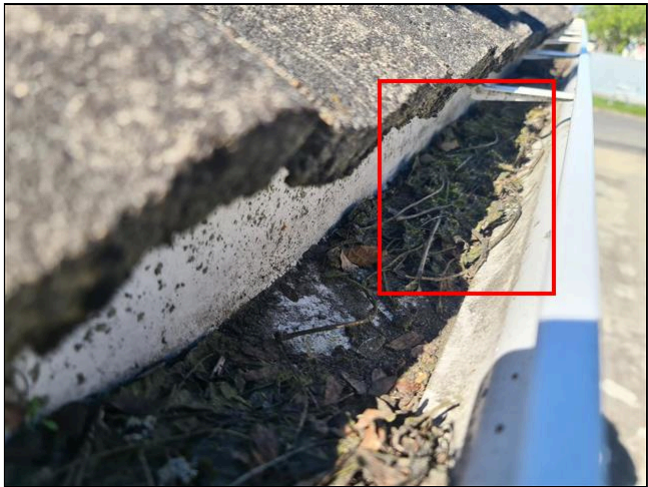
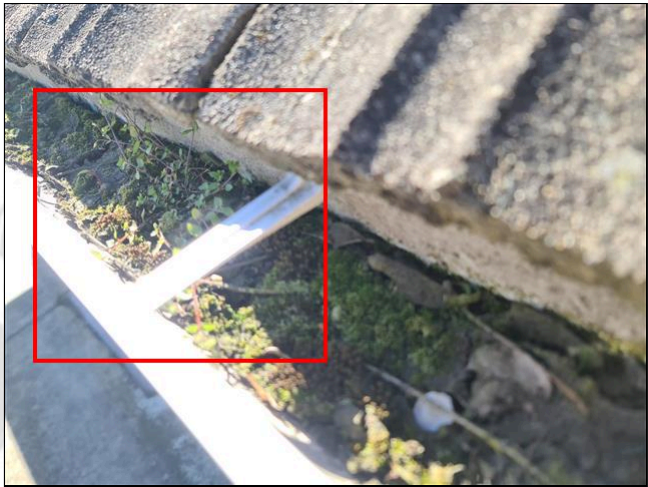
8.5 The gutter is almost blocked at the marked area, needs to be cleaned and tested again.

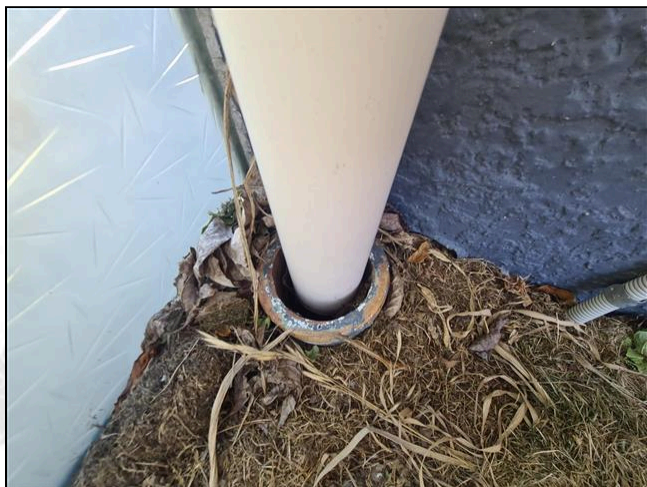
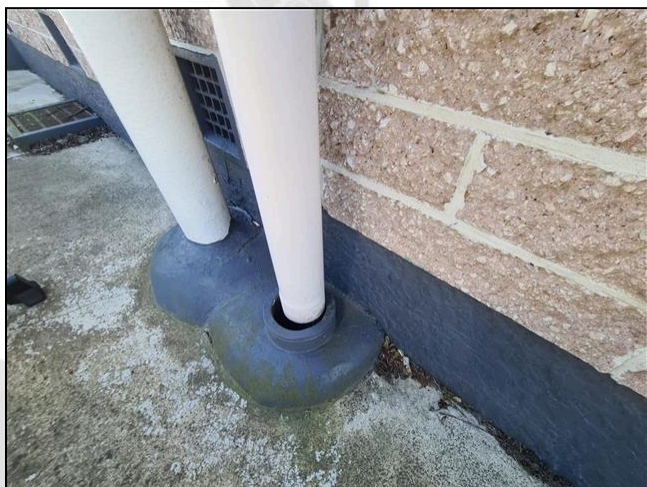
8.6 (2) The rest of the downpipes direct the rain water to the appropriate out falls.

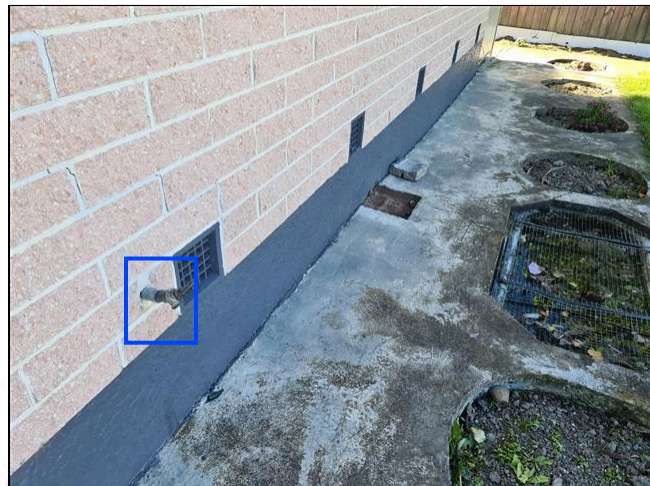
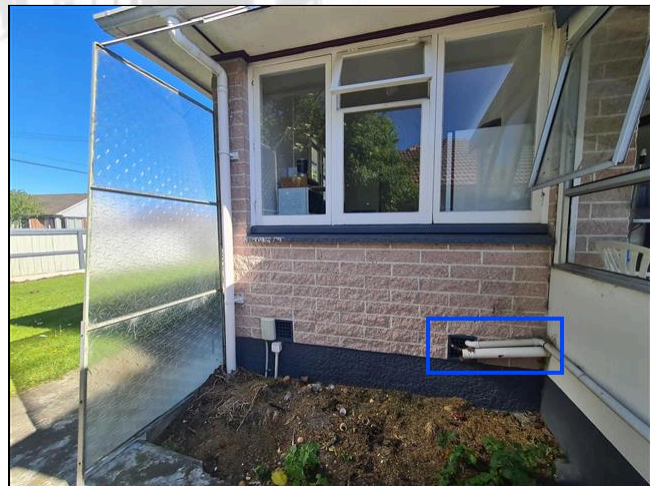
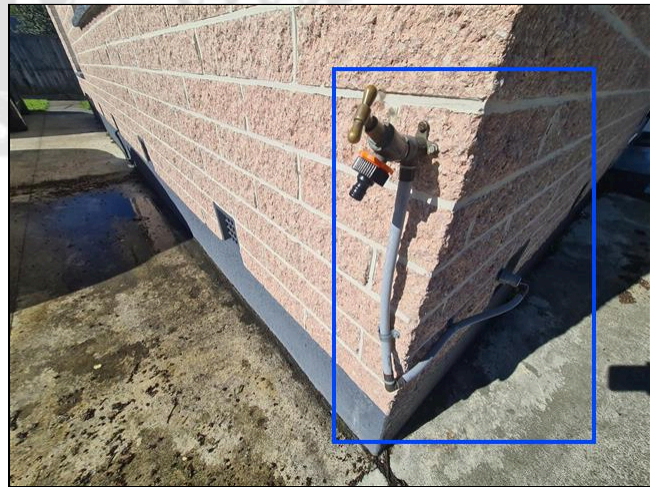
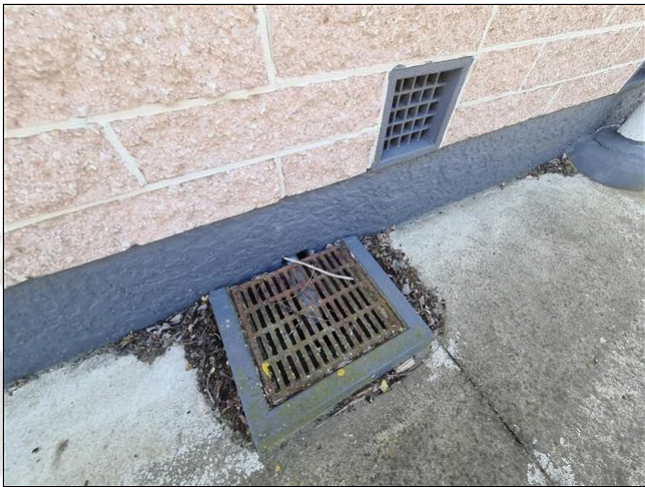
8.7 No leaking found near the gully traps and water pipes. Please understand that any areas blocked in terms of vision is not inspected.

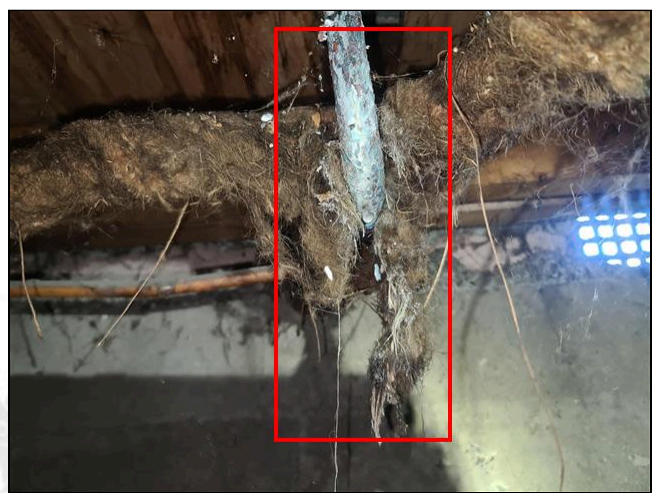
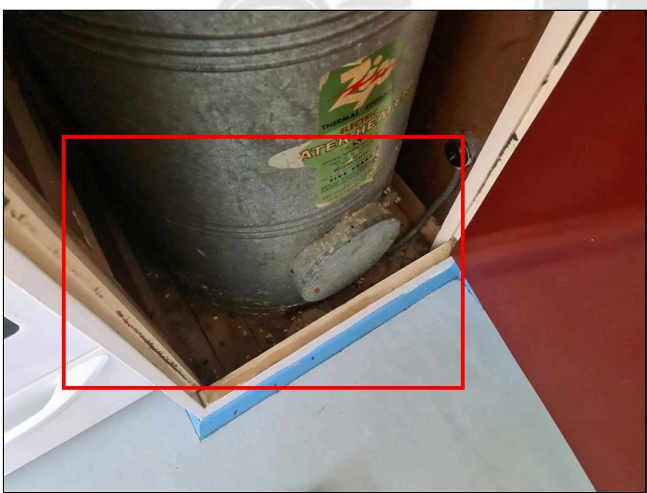
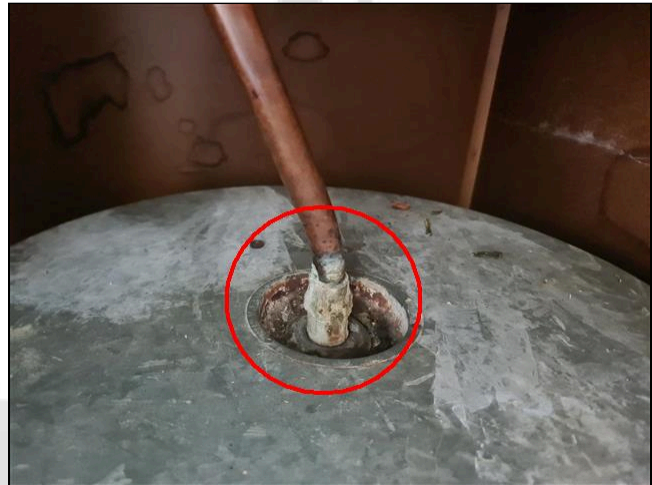
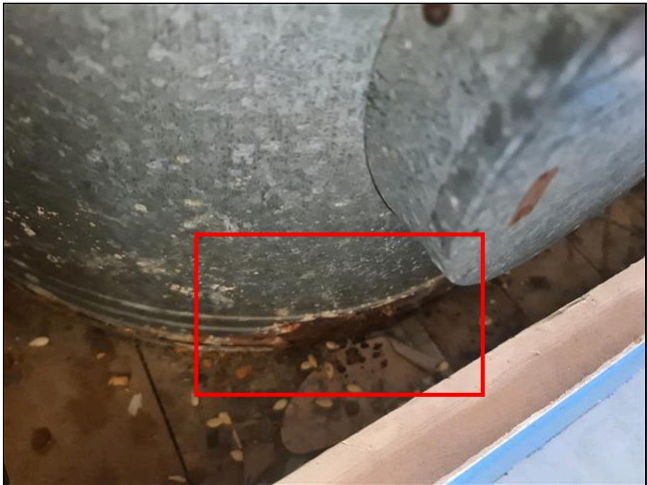
8.9 (1) The Hot water cylinder is consistently leaking to the subfloor. The hot water cylinder is due to be replaced, further plumbing action required.

(1) The Hot water cylinder is consistently leaking to the subfloor. The hot water cylinder is due to be replaced, further plumbing action required.

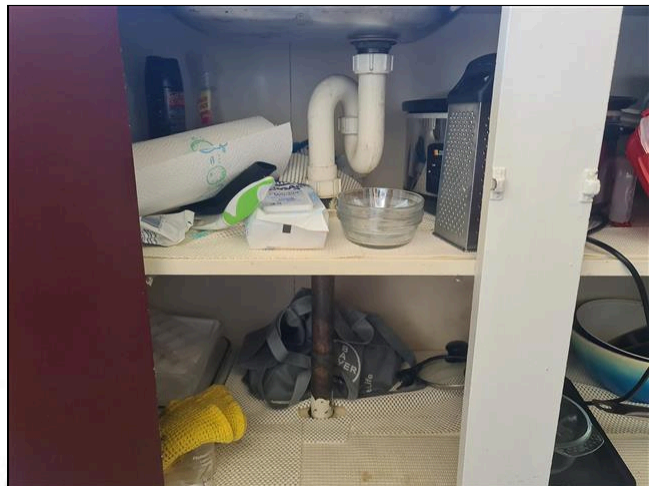
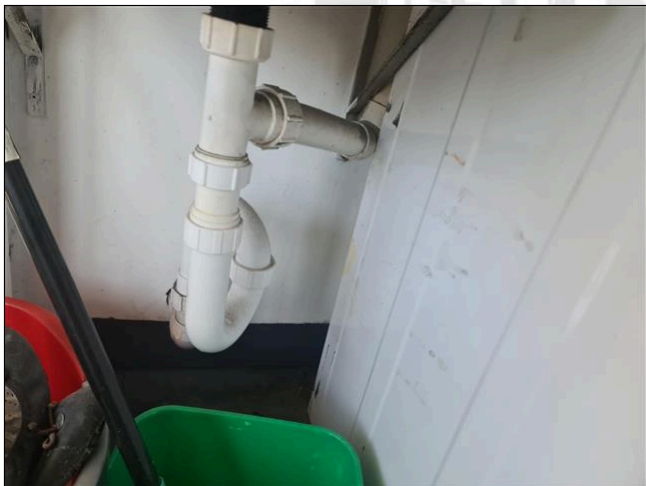
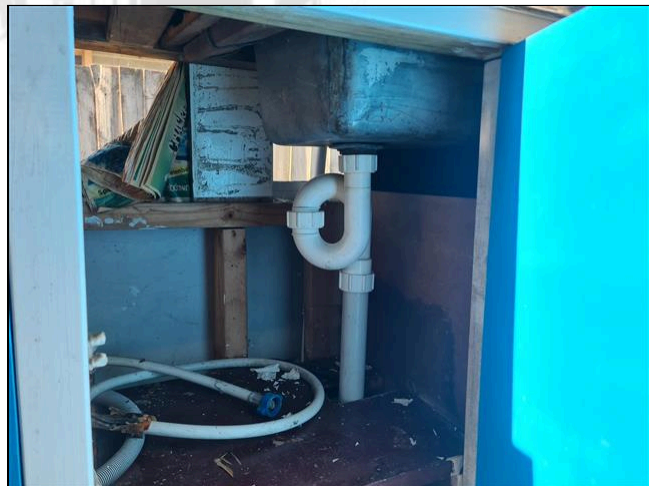
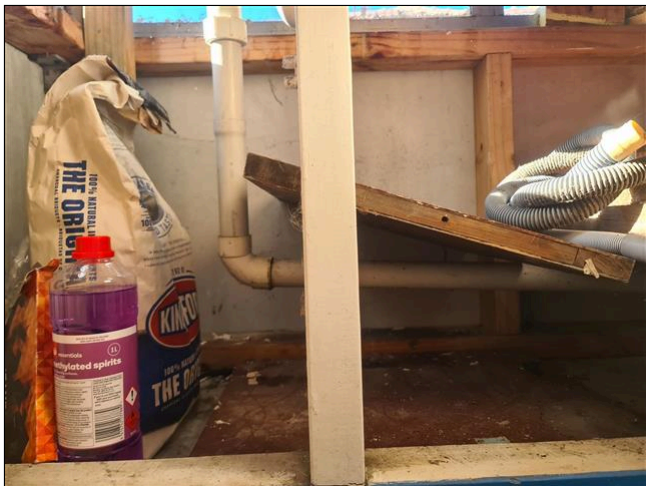
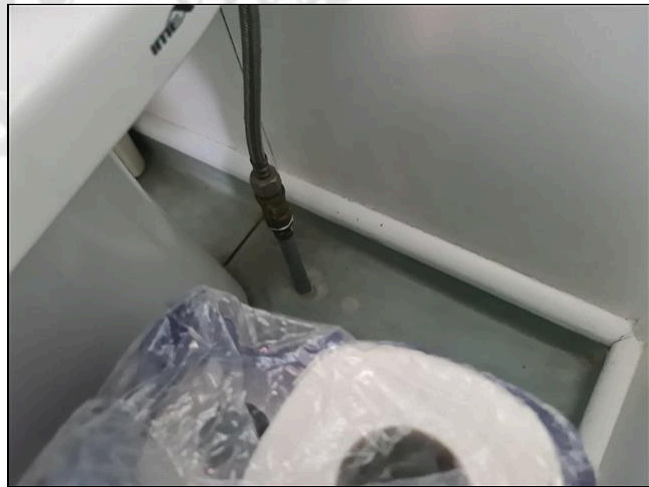
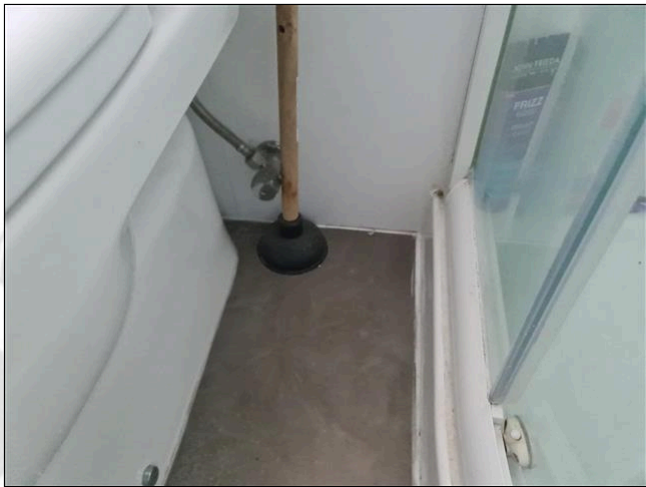
8.9 (2) No leaking found in the rest of the property, where near the toilet and under the sinks. Please understand that any areas blocked in terms of vision is not inspected.

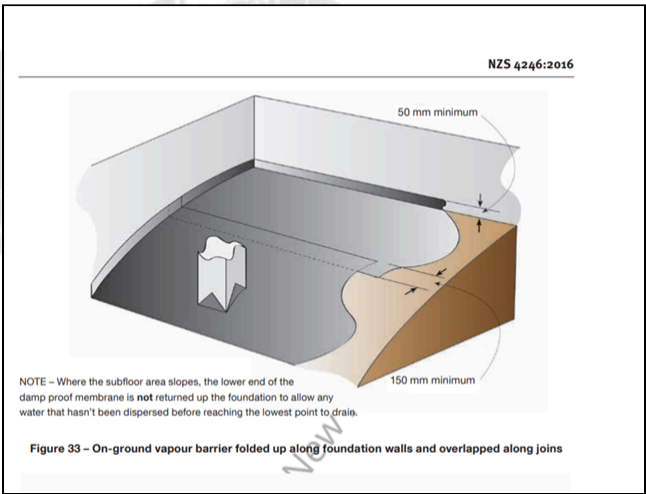
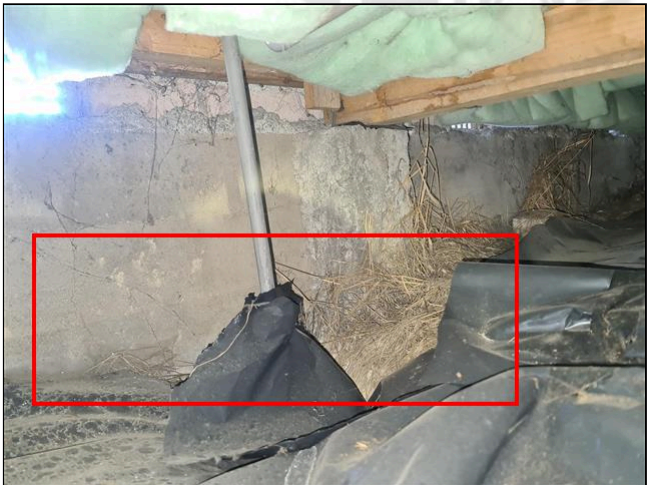
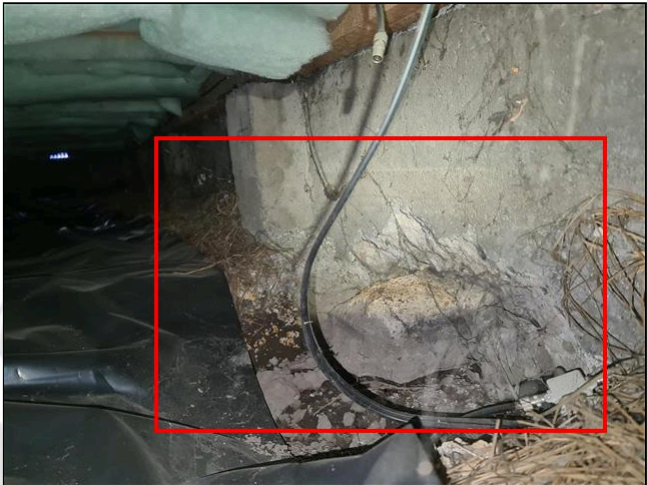
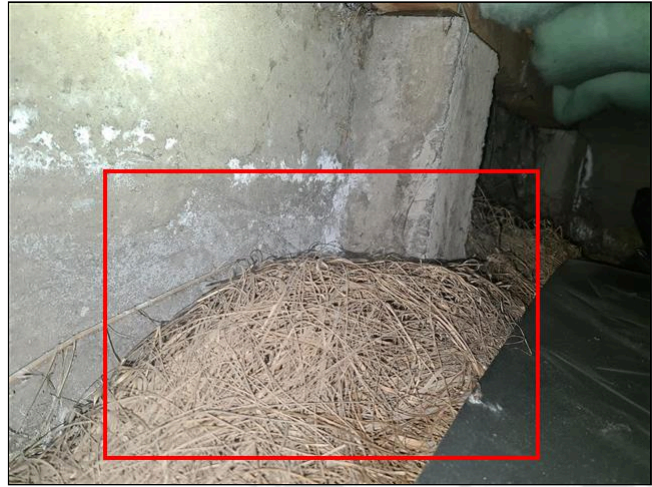
9.0 Missing ground moisture barrier in the subfloor around the concrete foundation walls.

Missing ground moisture barrier in the subfloor around the concrete foundation walls.

The Ground moisture barrier should be polythene film with a vapour flow resistance of no less than 50 MN s/g and a thickness of no less than 0.25mm. Suggest to use 250 micron polythene.

- Inside edge of the foundation walls and around the piles, There should be at least 50mm folded up polythene and taped to the piles.
- All joins and cuts should be taped, the tape should cover each side of the join at least 50mm.
- The overlap joins between polythene sheet should be at least 150mm.
- The overlaps and edges should be pinned or weight down at intervals of no more than 1m

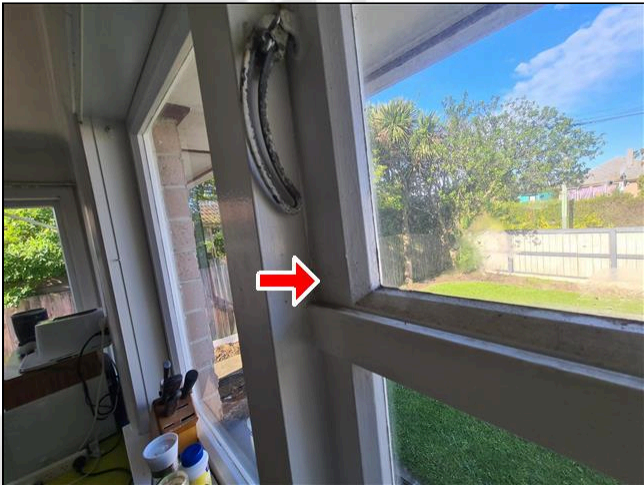
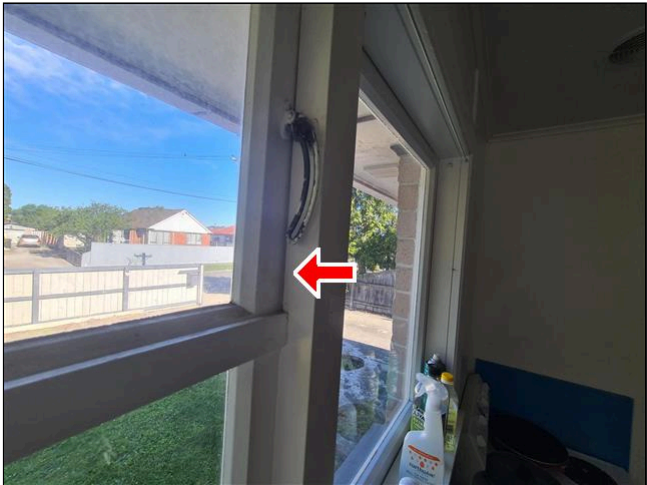
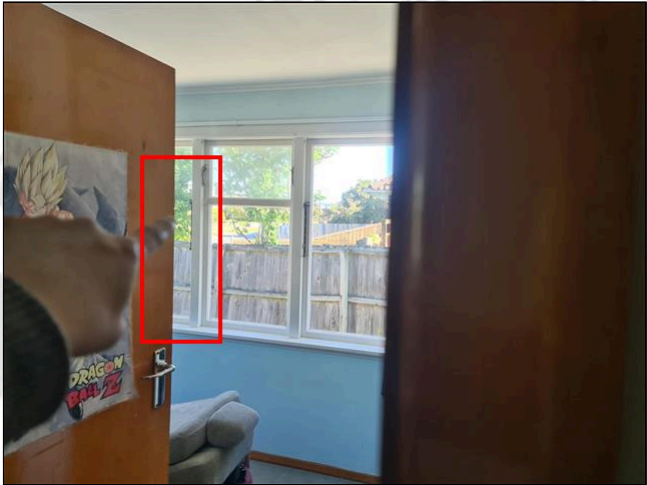
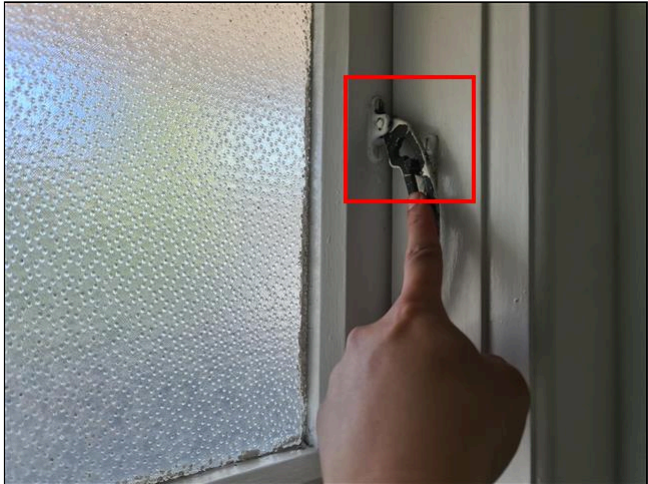
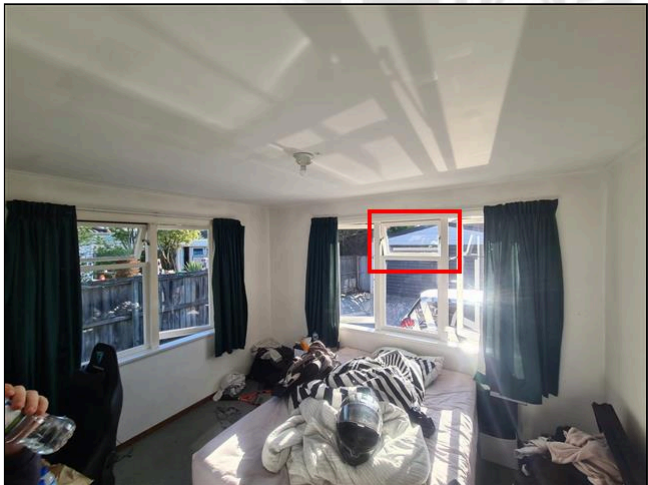
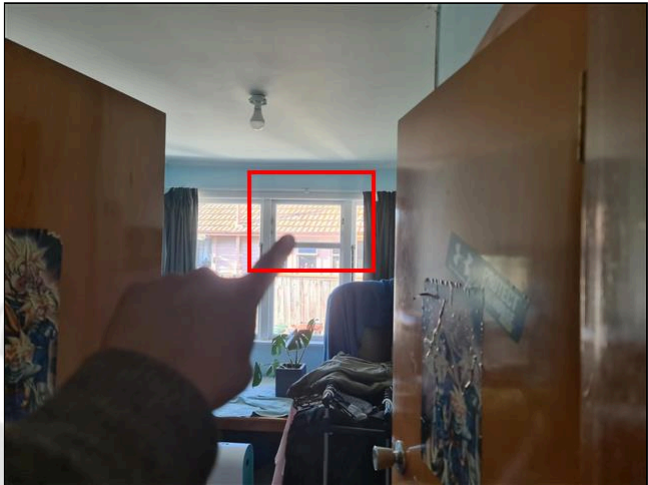
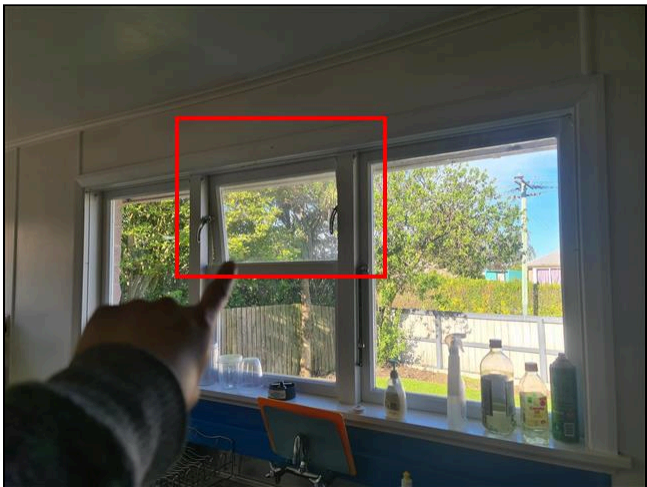
10.0 (1) Draughts found in the kitchen, bedroom 1,2,3, toilet, need to be sealed.

(1) Draughts found in the kitchen, bedroom 1,2,3, toilet, need to be sealed.

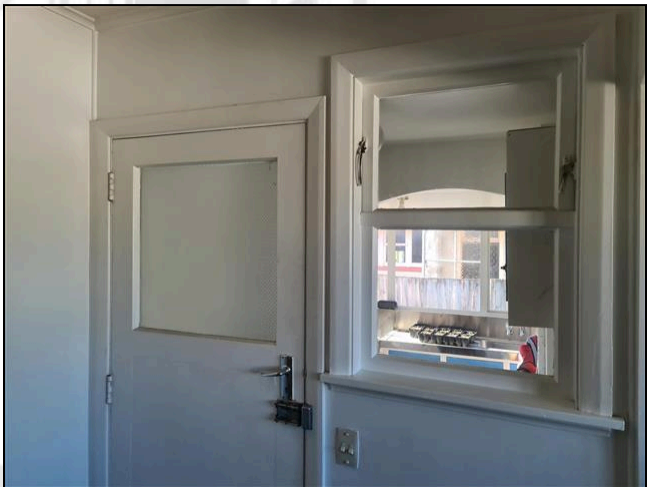
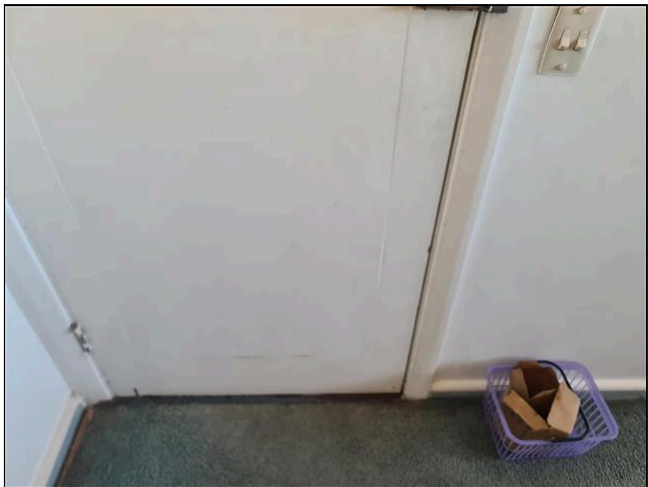
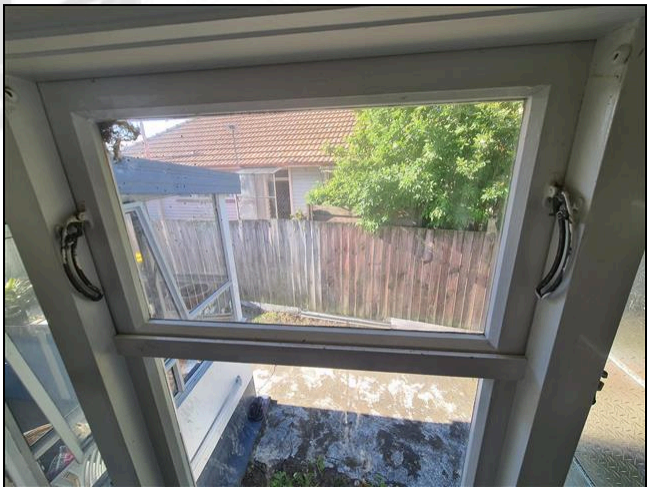
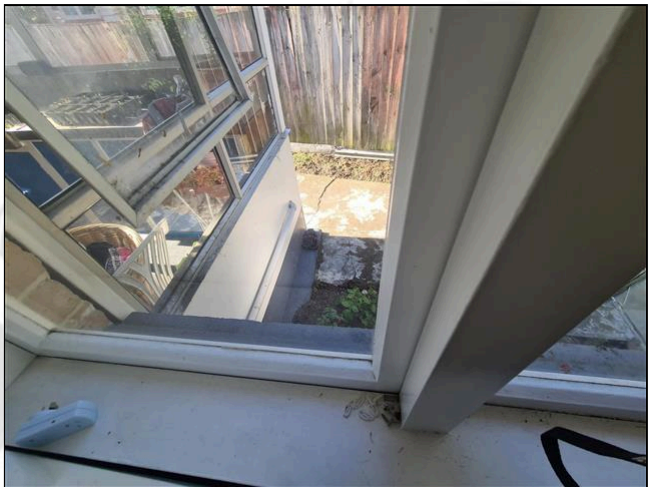
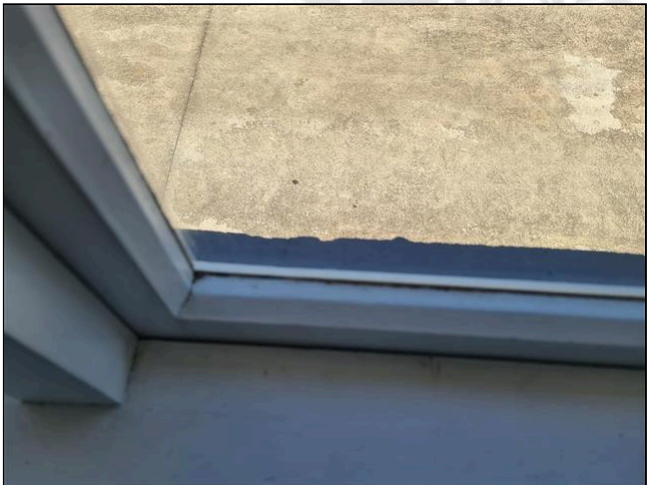
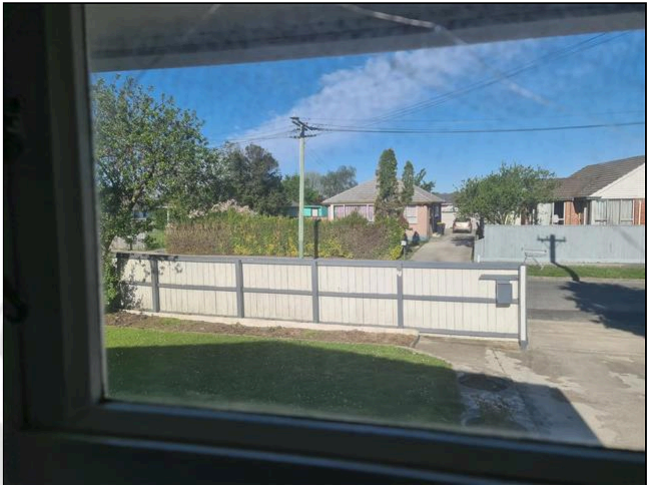
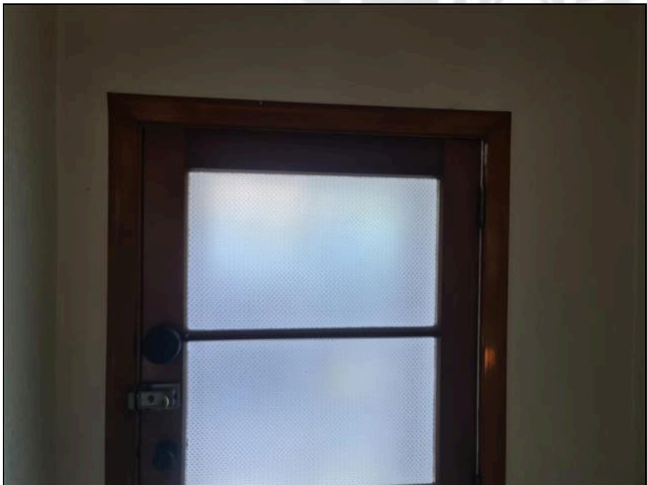
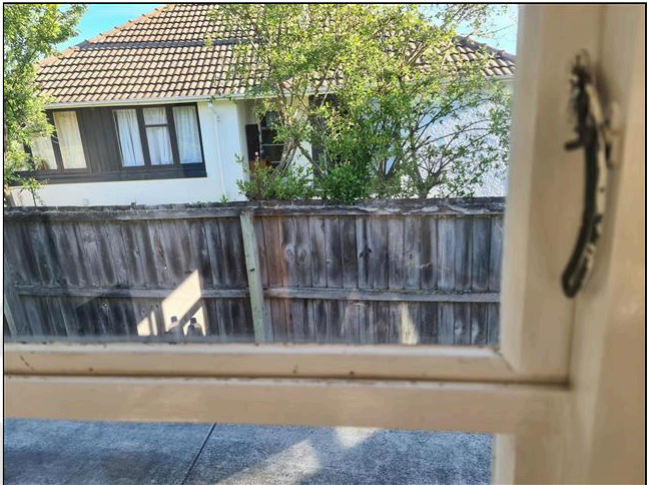
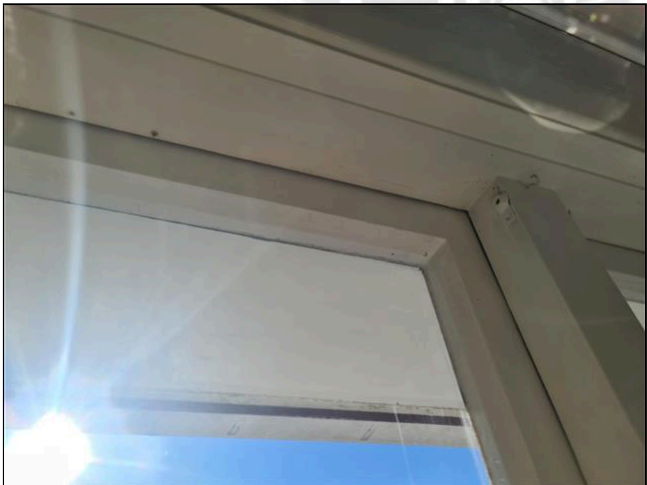
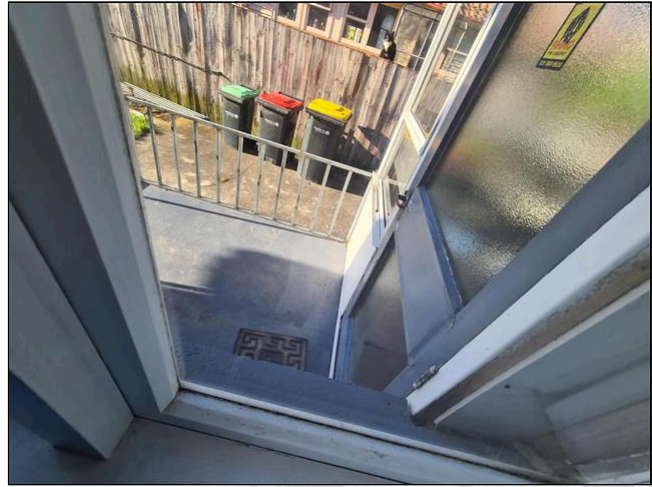
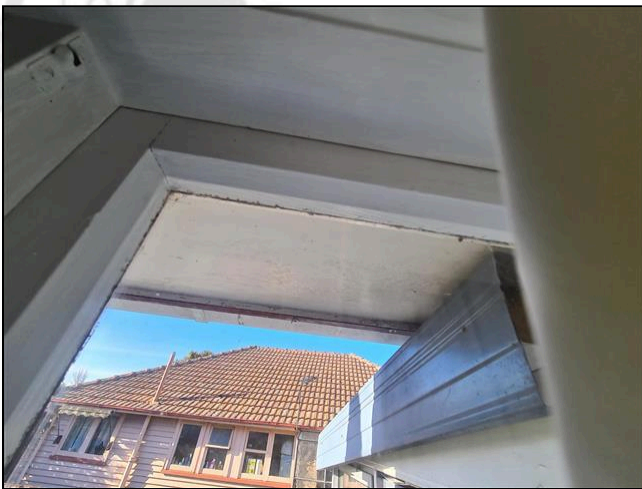
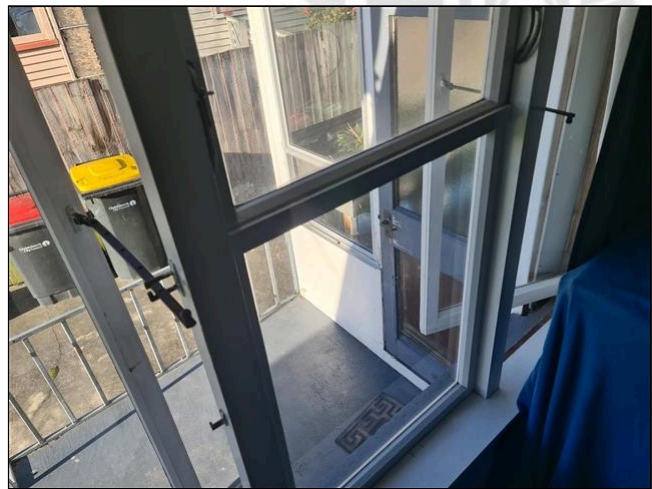
10.0 (2) No draught found in the rest of the property.

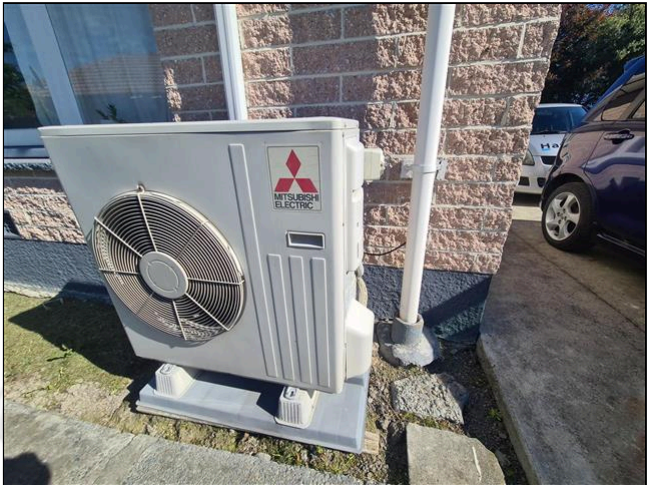
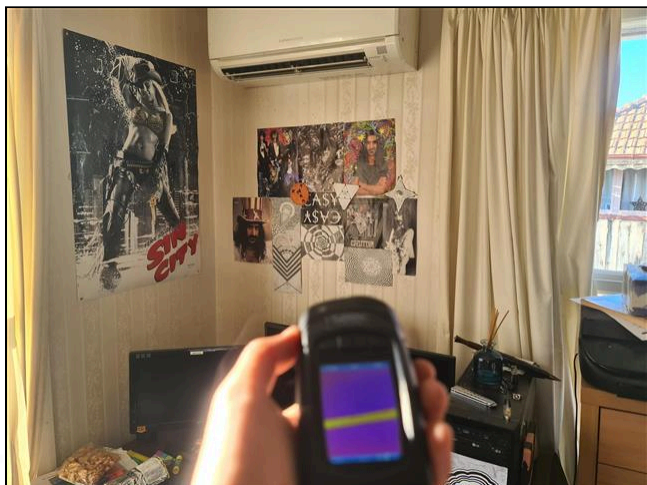
11.0 Primary heater details.

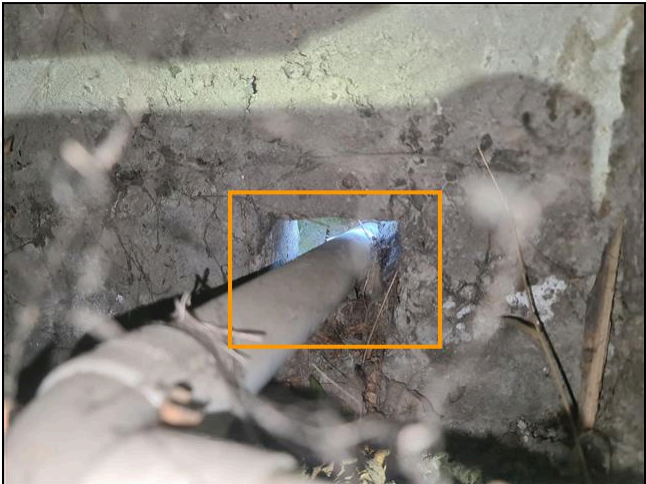
12.0 Item 1(Picture)

12.0 Potential rodent infesting access way found in the yellow marked area. Suggest to seal up.
