Healthy Homes Standards Assessment

Property Address: 31 Sample St, Fendalton, Christchurch, Can 8014

20211102-31-Sample-St

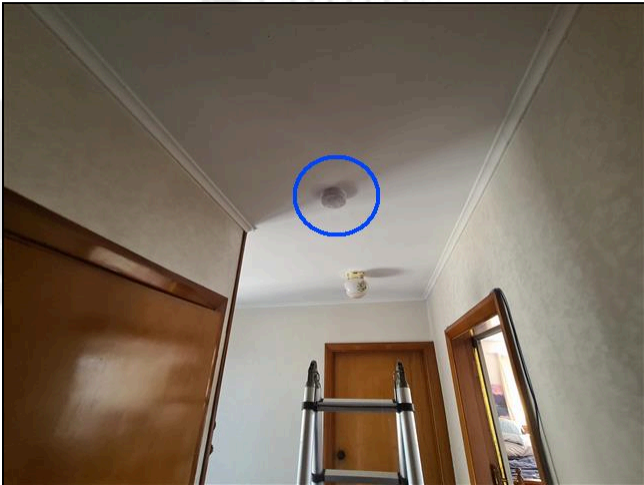
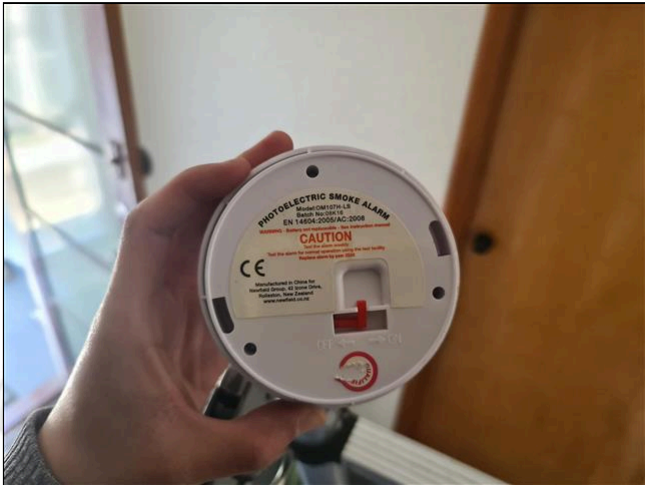
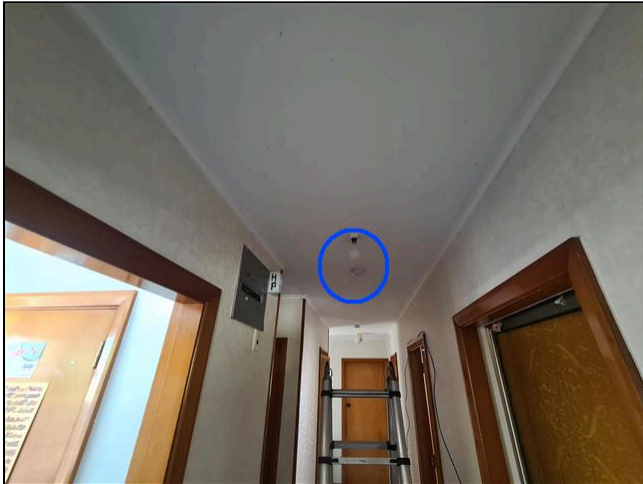
2.0 hallway smoke alarm long-life battery expire in 2026.

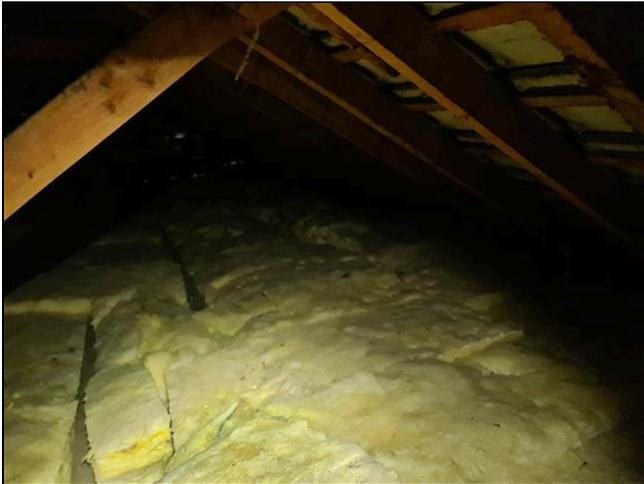
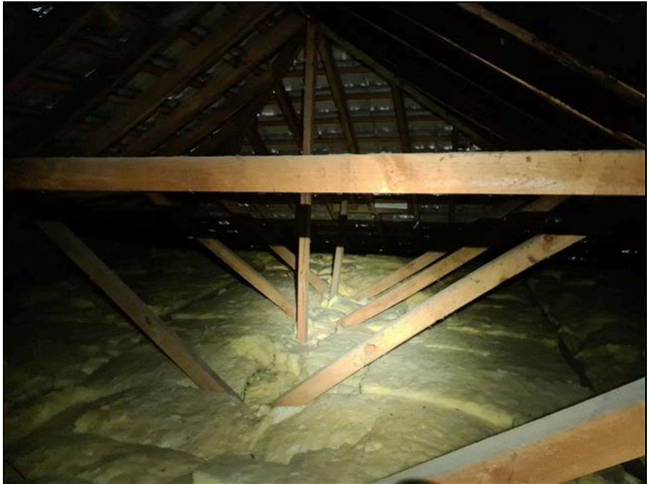
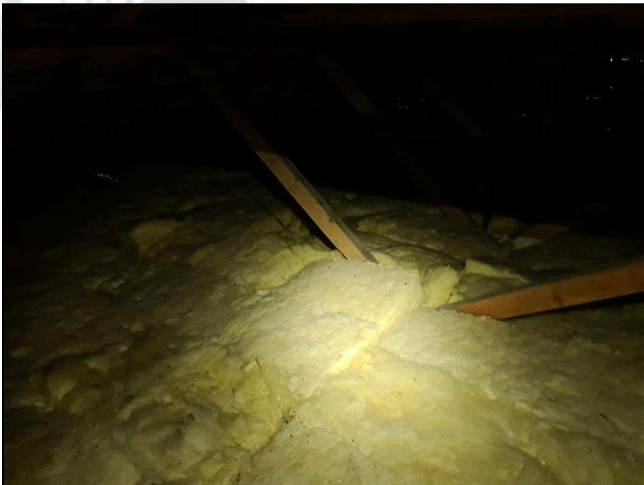
3.0 There are old loose-fill type insulation and recently installed Bradford Gold fibreglass ceiling R3.6 insulation present in the roof cavity. The R3.6 ceiling insulation segments are over 180mm. Overall, The total thickness of loose-fill type insulation and fibreglass insulation is above the requirement of Healthy homes standards-R3.3.

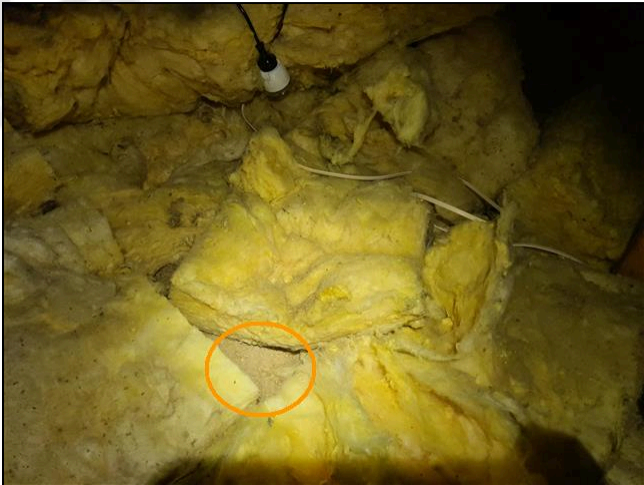
3.1 Item 1(Picture)

3.1 Insulation with gaps, some are piled up, and some are scattered around, However not in major.

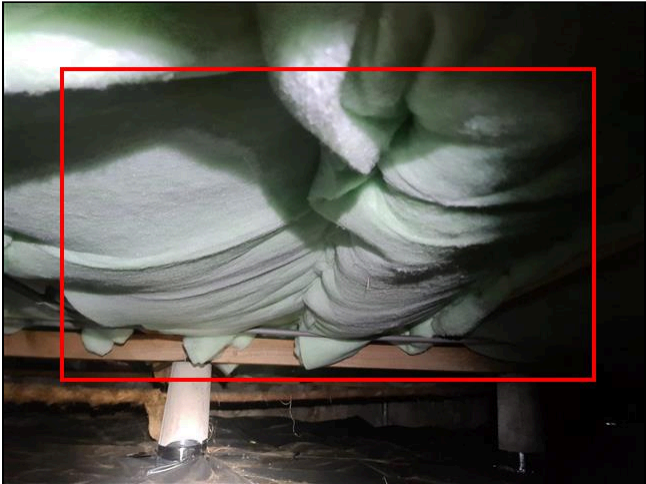
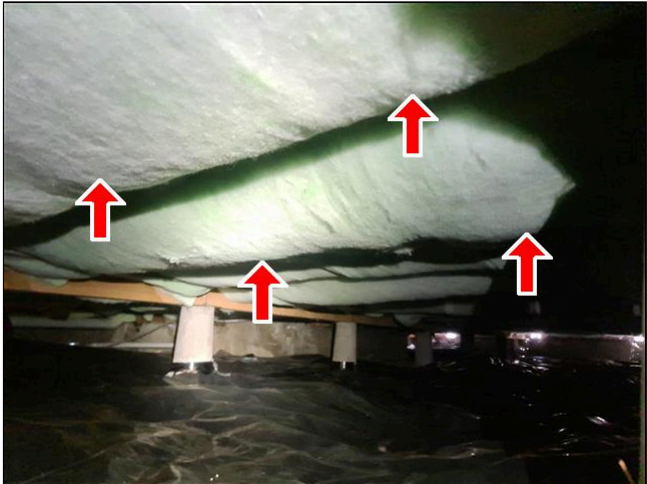
4.1 There are missing insulation close to the foundation concrete. And about 2/3 insulation has been installed with air gaps.

There are missing insulation close to the foundation concrete. And about 2/3 insulation has been installed with air gaps.

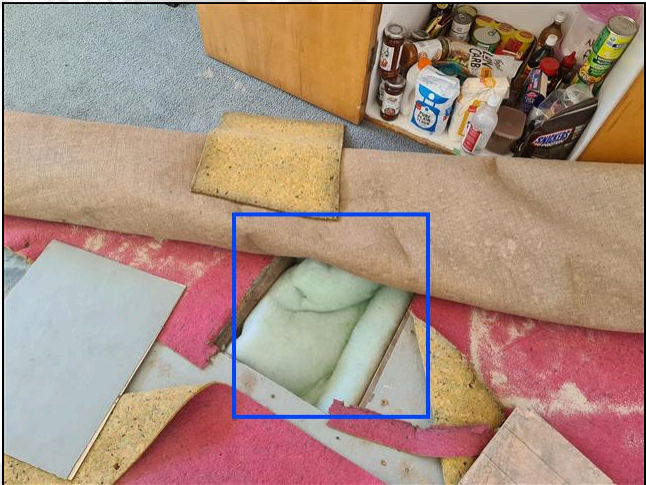
4.2 Item 1(Picture)

4.2 Manhole cover with R1.5 underfloor insulation.

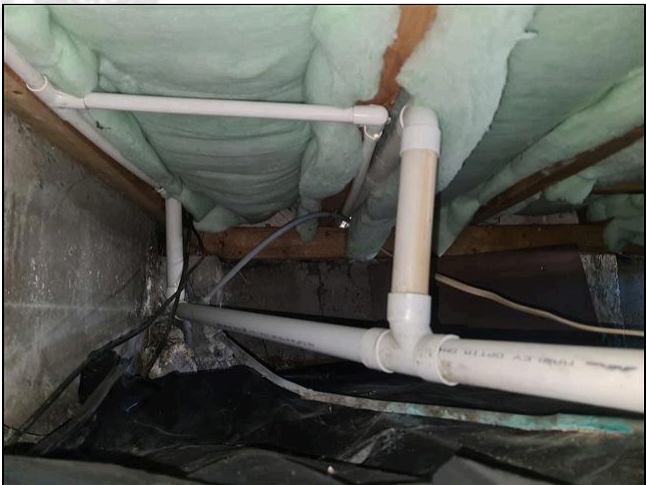
4.3 Item 1(Picture)

4.3 Correct distance around objects in the subfloor.

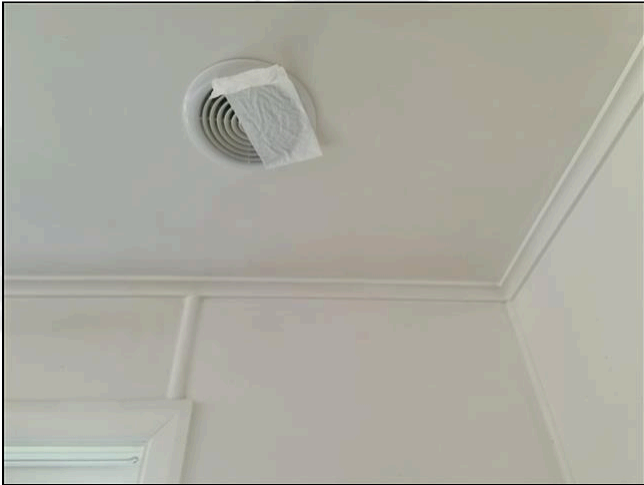
5.0 Item 1(Picture)

5.0 Rangehood in the kitchen.

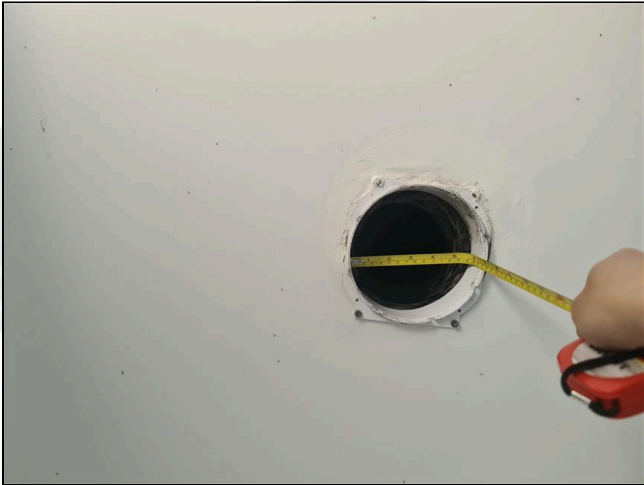
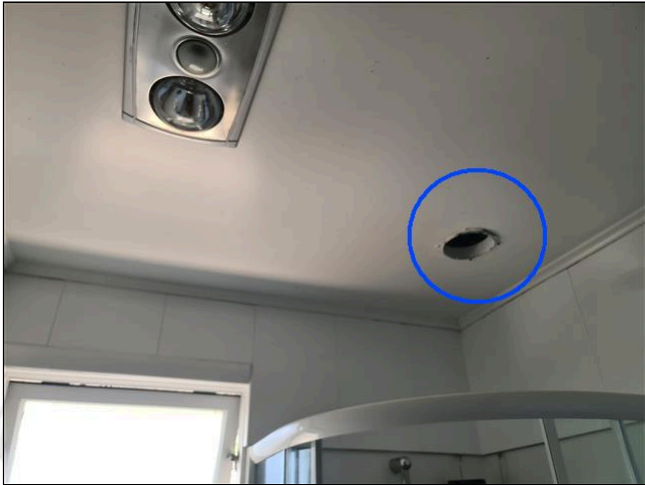
6.0 Bathroom fan in blue area. 3 in 1 unit fan is not working.

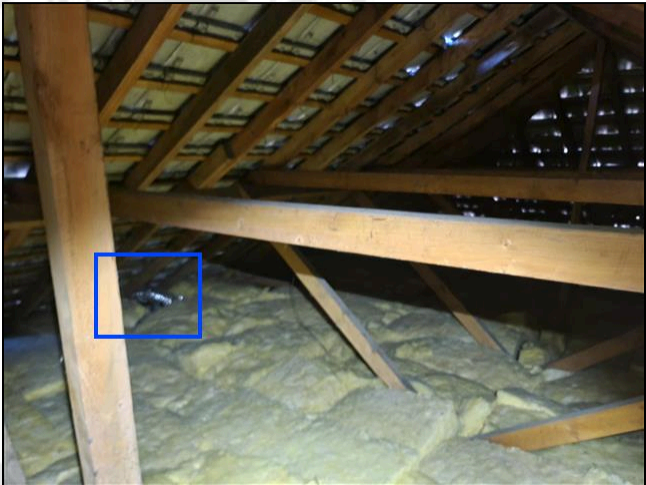
6.2 Item 1(Picture)

6.2 Bathroom ducting pipe in the roof cavity.

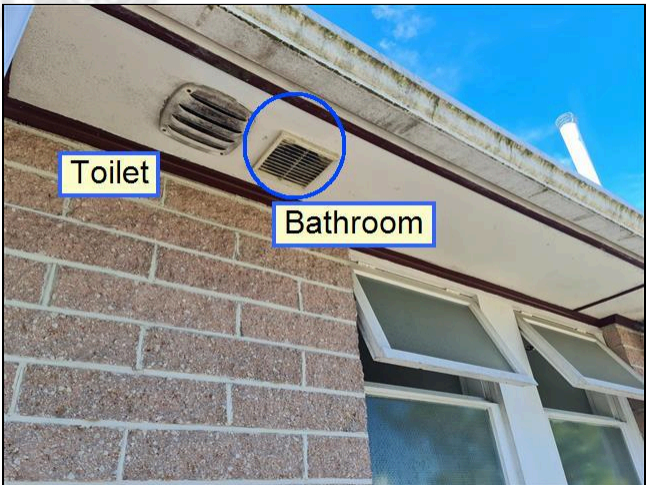
6.3 Item 1(Picture)

6.3 Bathroom fan external vent in blue area. air flows out when rangehood is working.

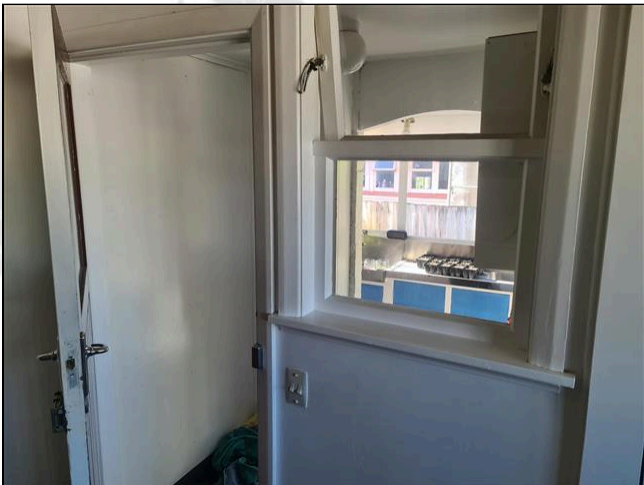
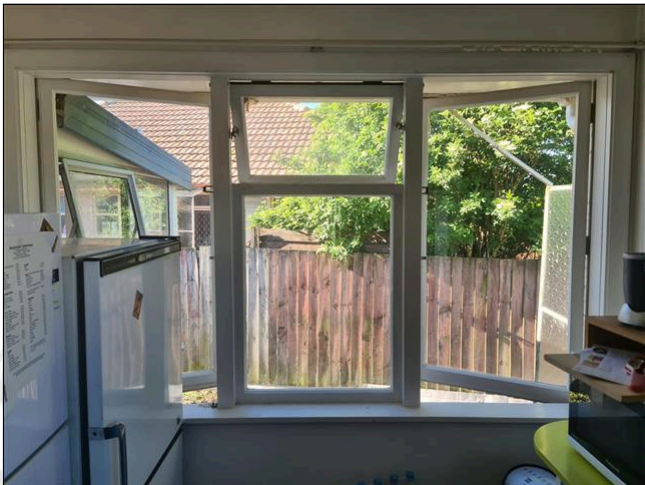
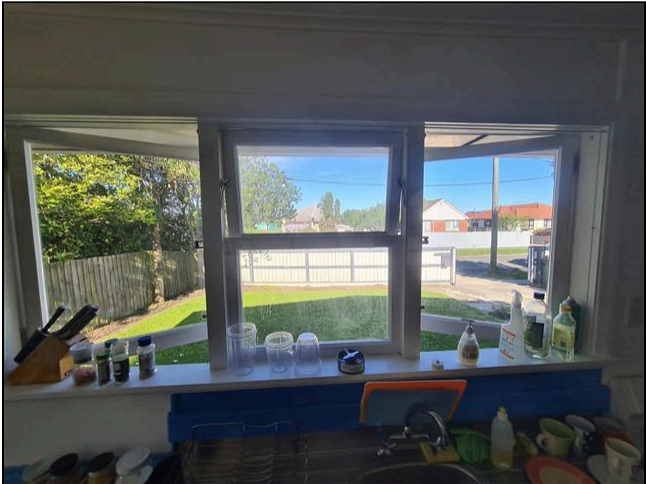
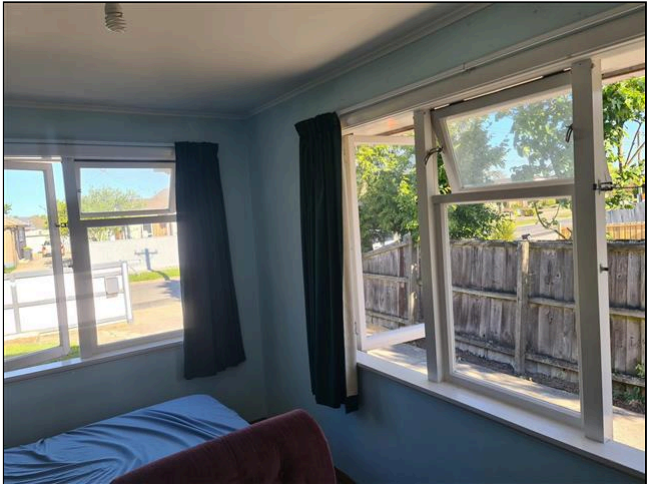
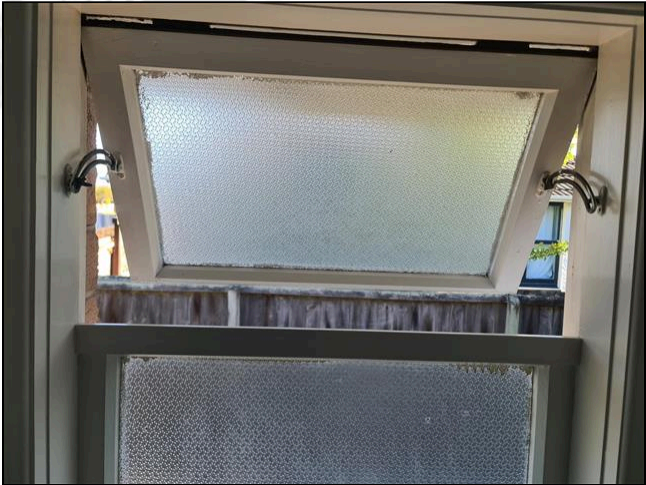
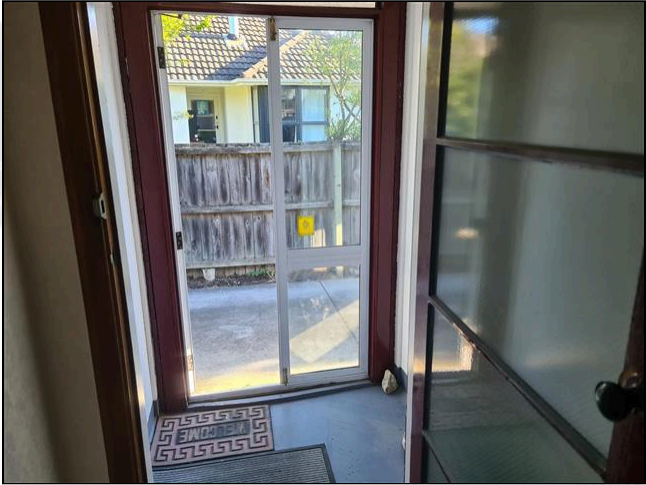
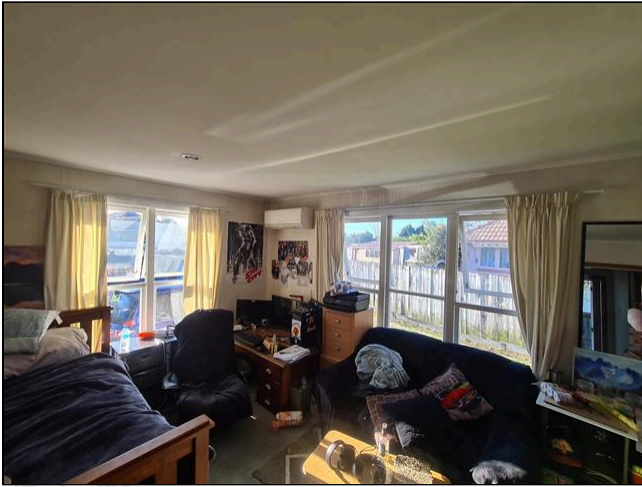
7.0 Openable windows.

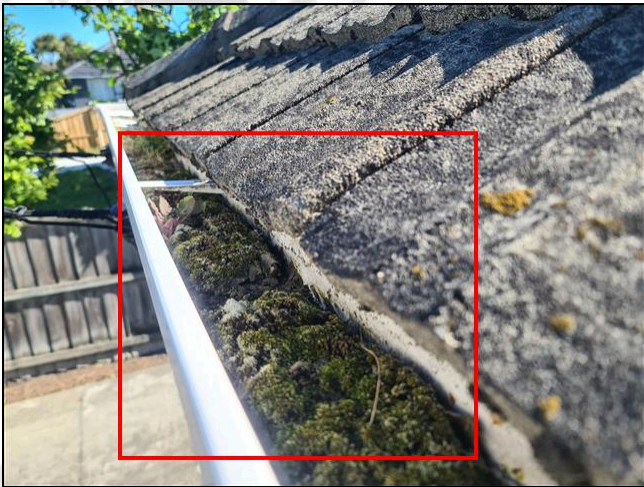
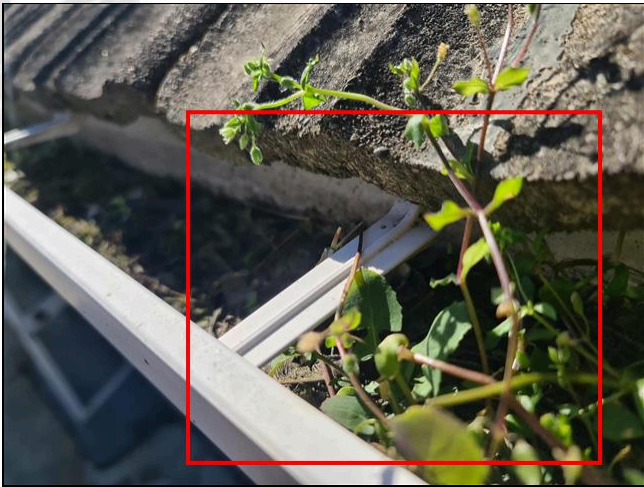
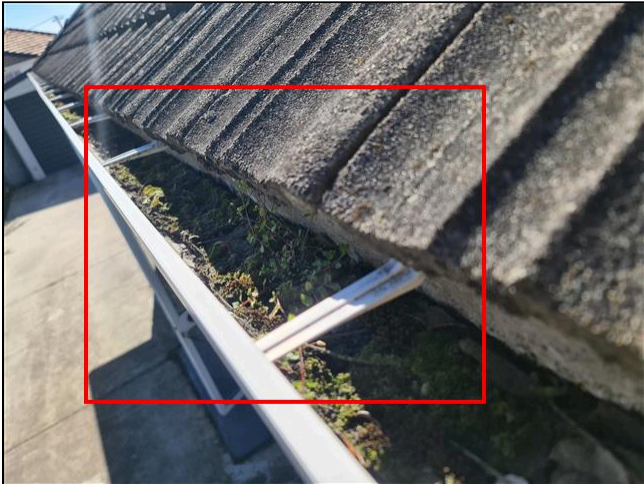
8.5 The gutter is almost blocked at the marked area, needs to be cleaned and tested again.

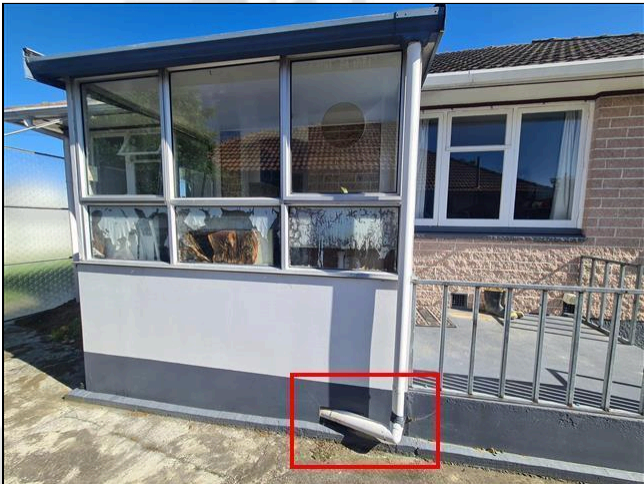
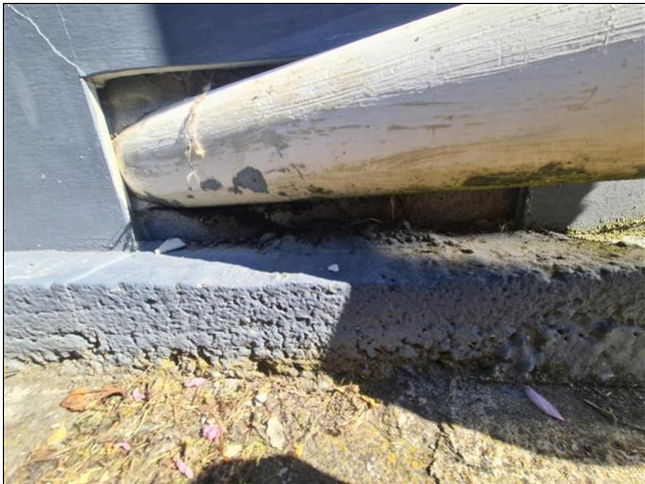
8.6 (1) Unable to check where the downpipe outside the laundry goes into, Please provide the storm water drainage plan for further action.

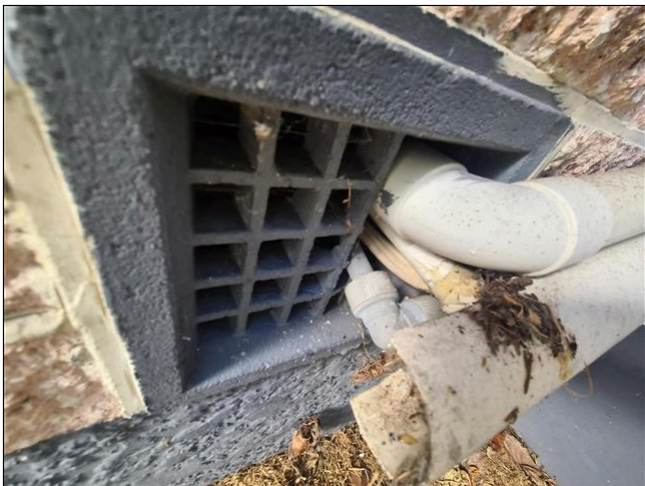
8.7 No leaking found near the gully traps and water pipes. Please understand that any areas blocked in terms of vision is not inspected.

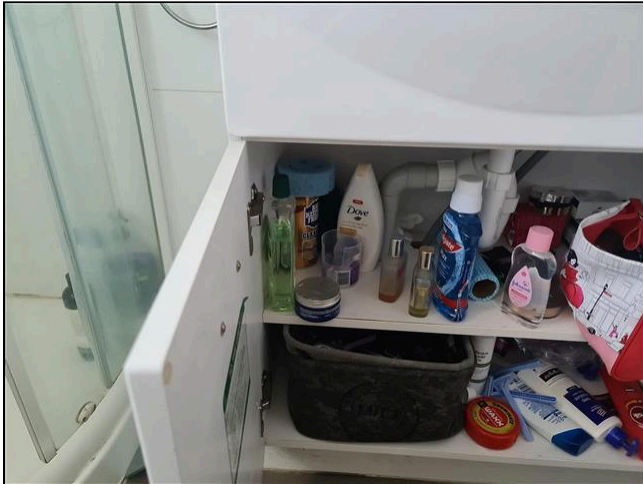
8.9 Item 11(Picture)

8.9 (2) No leaking found in the rest of the property, where near the toilet and under the sinks. Please understand that any areas blocked in terms of vision is not inspected.

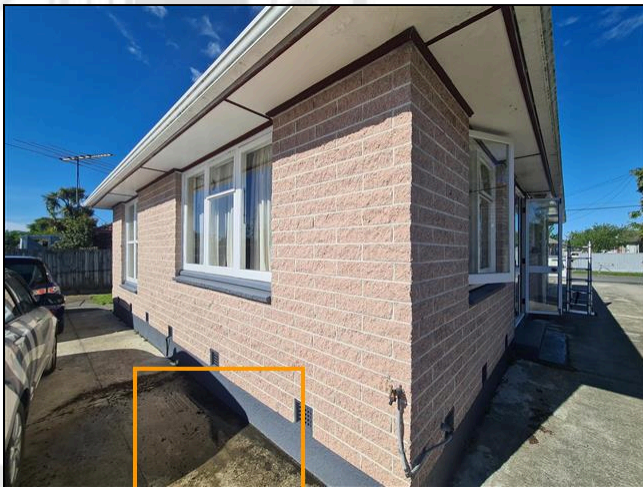
8.10 Item 1(Picture)

8.10 There are some surface water on the concrete path, it may be from the water tap in the corner.

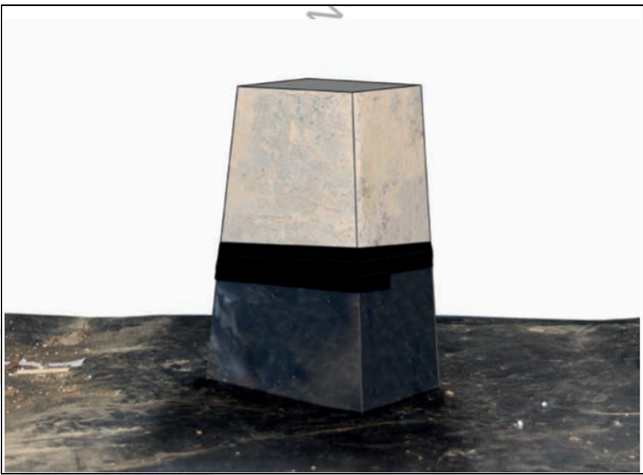
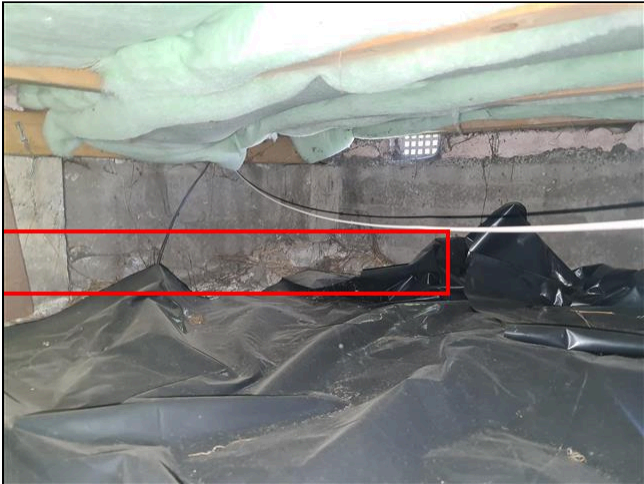
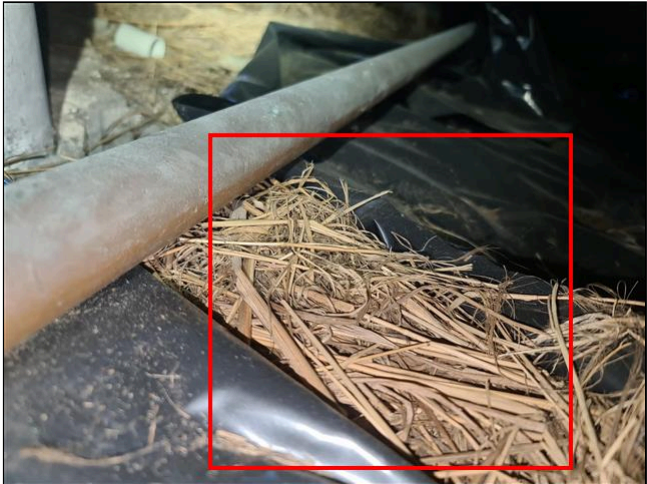
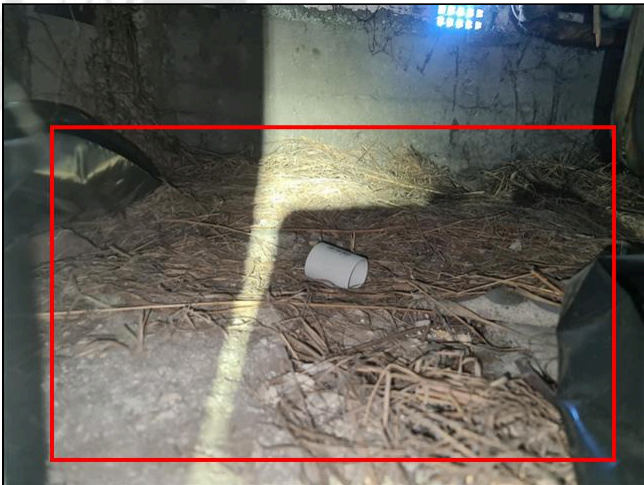
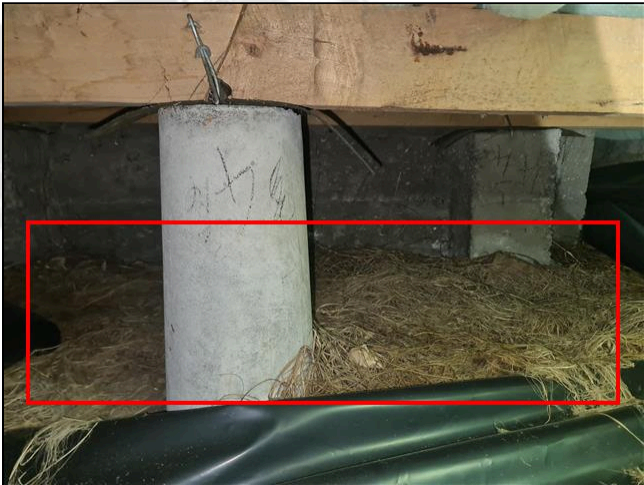
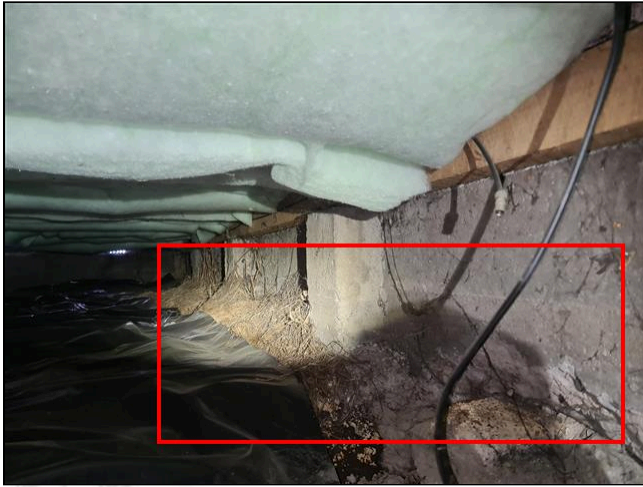
9.0 Missing ground moisture barrier in the subfloor around the concrete foundation walls.

Missing ground moisture barrier in the subfloor around the concrete foundation walls.

The Ground moisture barrier should be polythene film with a vapour flow resistance of no less than 50 MN s/g and a thickness of no less than 0.25mm. Suggest to use 250 micron polythene.

- Inside edge of the foundation walls and around the piles, There should be at least 50mm folded up polythene and taped to the piles.
- All joins and cuts should be taped, the tape should cover each side of the join at least 50mm.
- The overlap joins between polythene sheet should be at least 150mm.
- The overlaps and edges should be pinned or weight down at intervals of no more than 1m

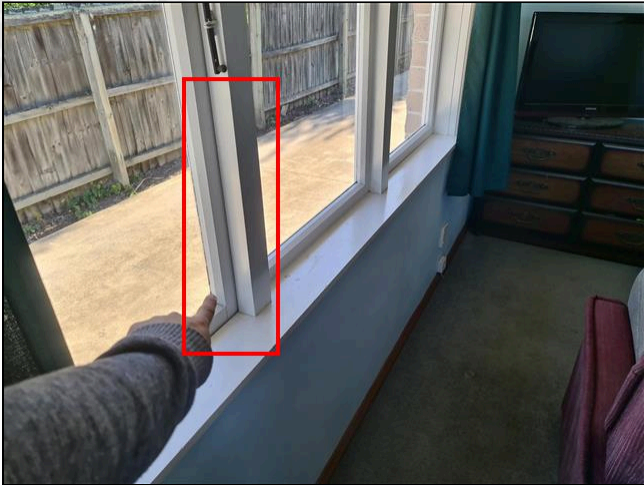
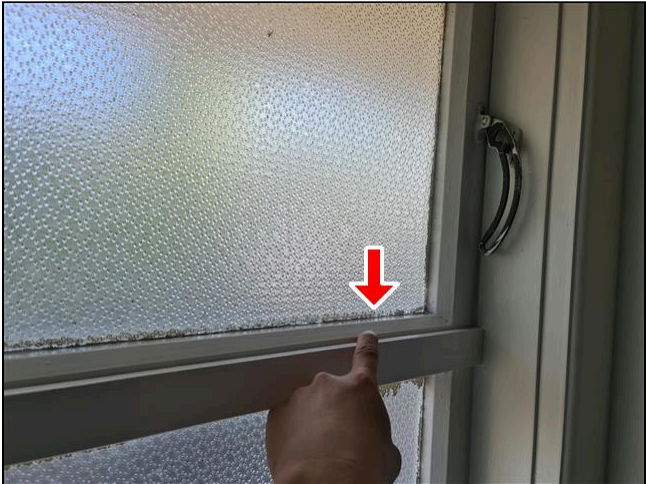
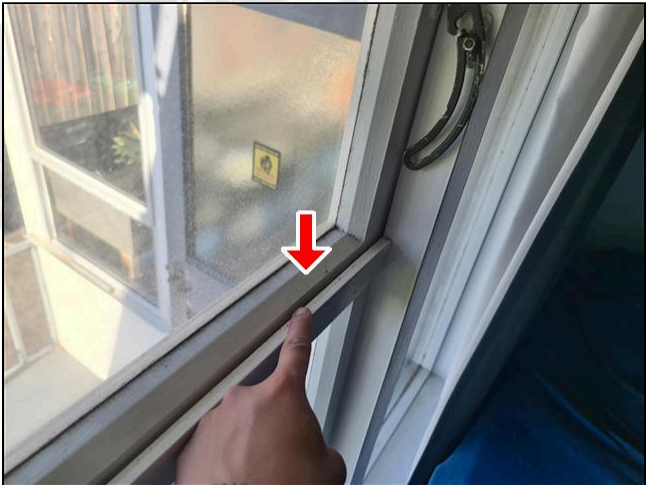
10.0 (1) Draughts found in the kitchen, bedroom 1,2,3, toilet, need to be sealed.

(1) Draughts found in the kitchen, bedroom 1,2,3, toilet, need to be sealed.

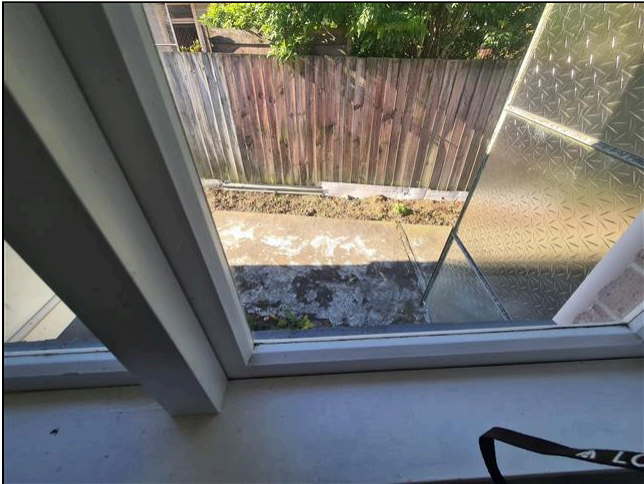
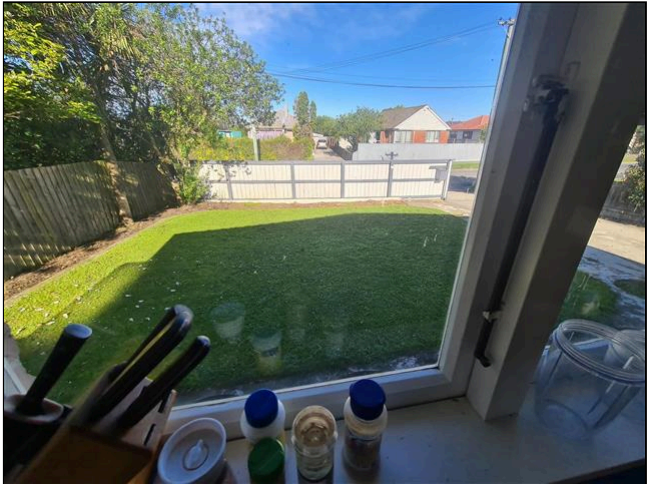
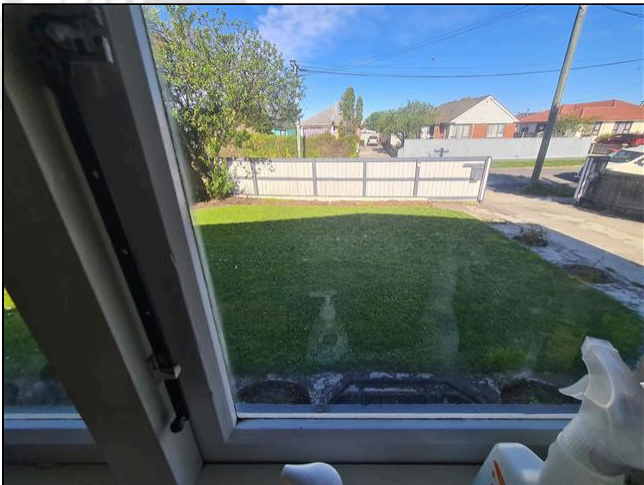
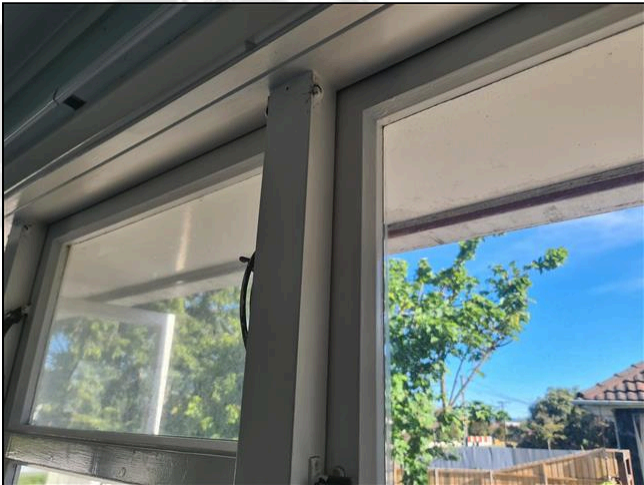
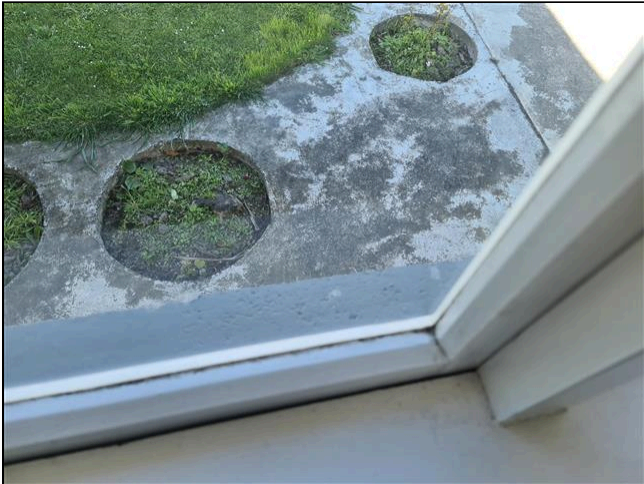
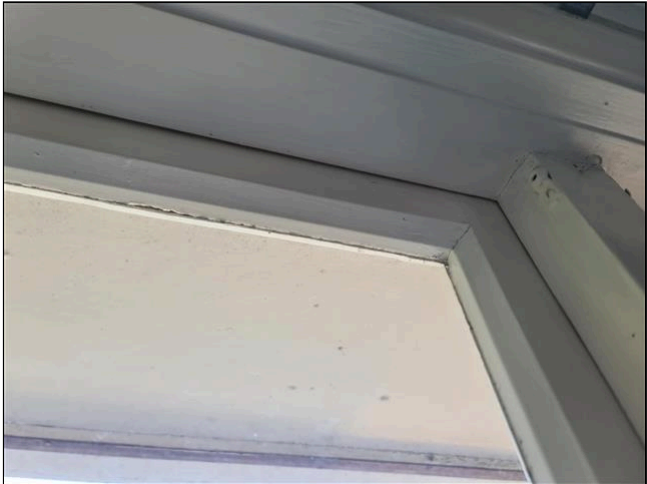
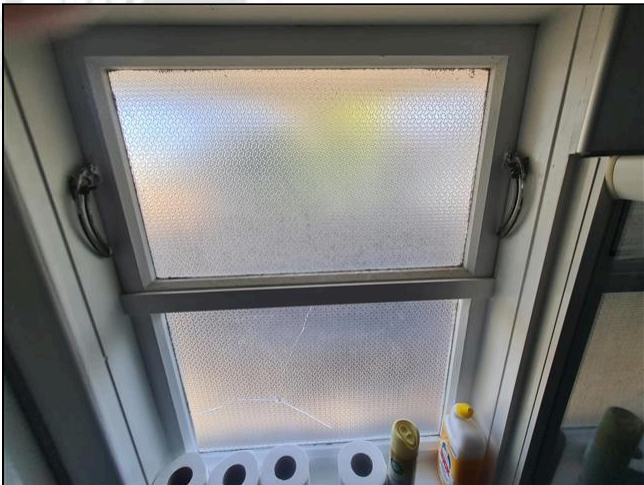
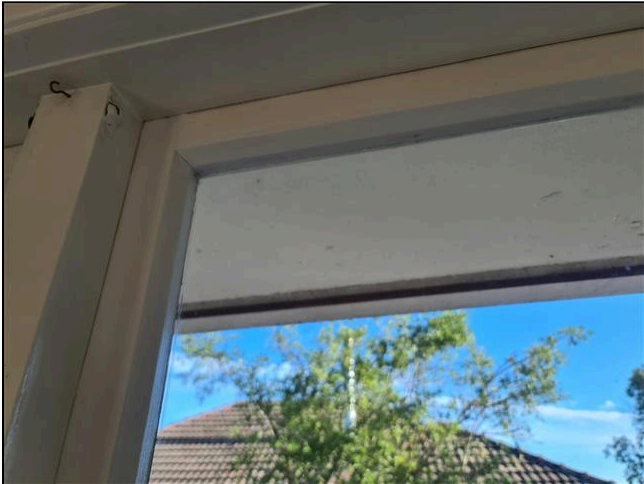
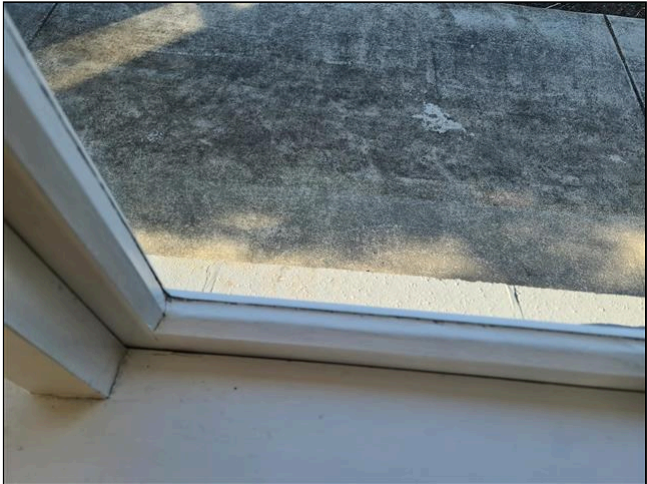
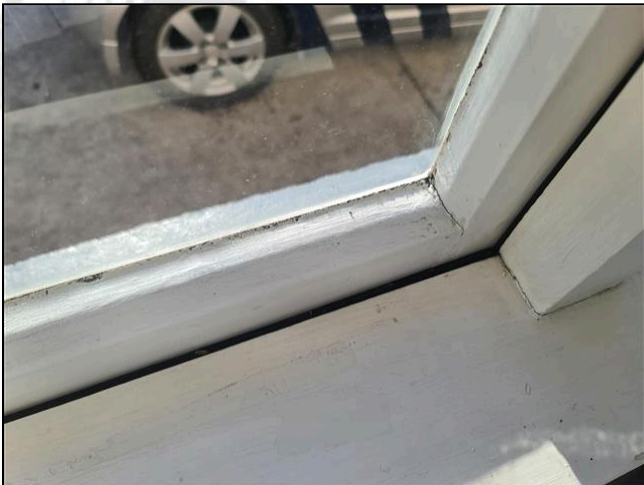
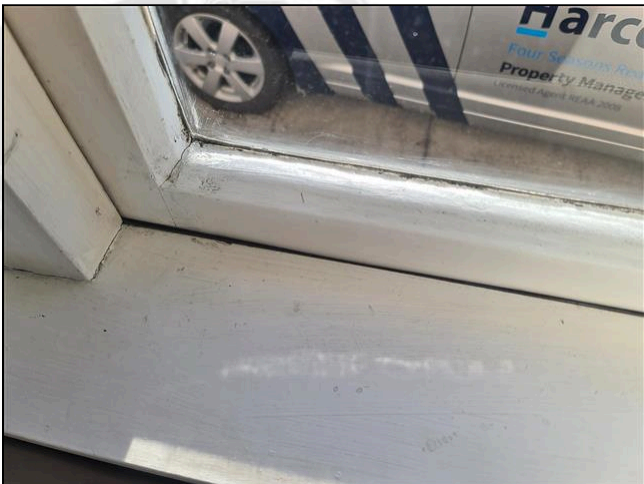
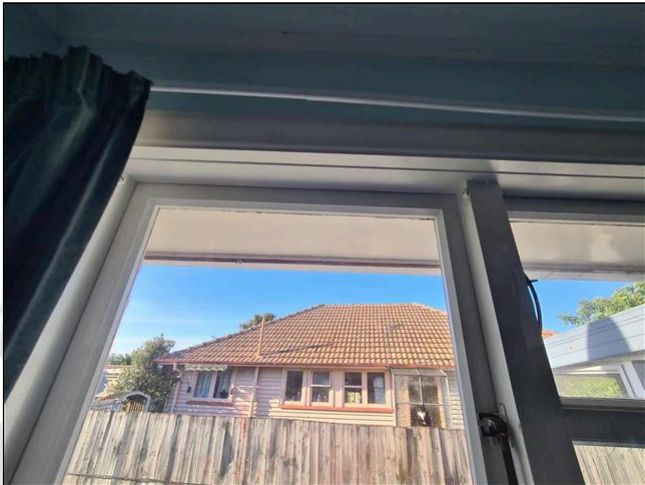
10.0 (2) No draught found in the rest of the property.

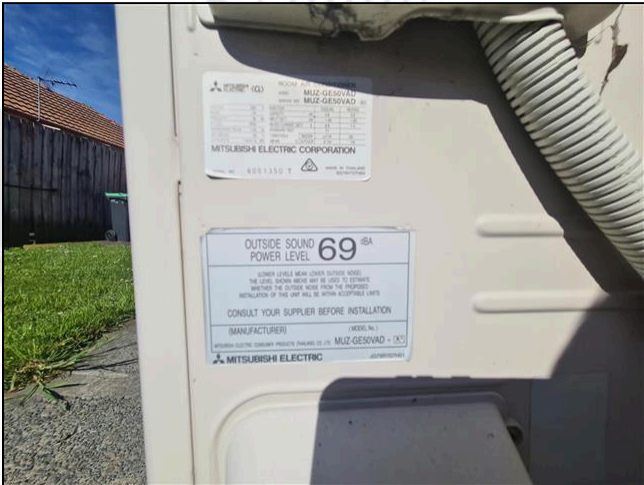
11.0 Primary heater details.
